Machine shop motor failures

Application Note

Power Quality Case Study

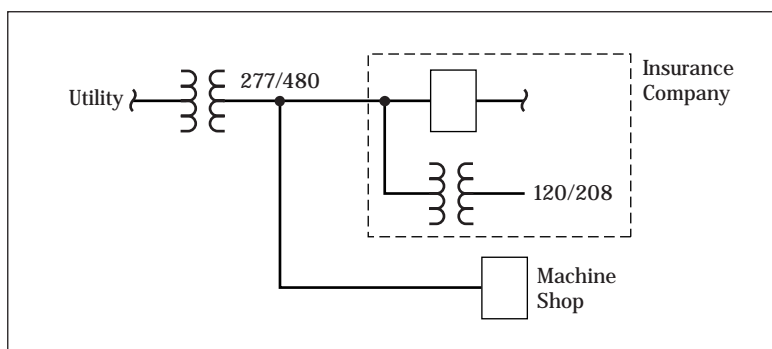
The machine shop itself hadn't undergone any changes. But an insurance company had moved into a new building next door. And they had done so at about the time when the motor failures began. The same utility transformer supplied both buildings (see Fig. 1).

Fig. 1 Utility connections for the machine shop and insurance company

the voltage waveform was flat-topped, with a total harmonic distortion (THD) of 7.8 %. It's significant to note that the 5th harmonic was the dominant bar on the harmonics display — a fact key to the analysis of the problem.

In the case of the machine shop, non-linear loads in the neighboring insurance building caused 5th harmonic distortion on the supply voltage. Computer and office machine loads connected to the 120 V receptacles were generating 3rd, 5th, 7th, 9th, and 11th harmonic currents. When these currents reached the 120/208 V transformer, the balanced portion of the zero sequence harmonics (e.g., 3rd, 9th) were trapped in the delta primary but the 5th, 7th, and 11th passed through. These reached the secondary of the utility transformer, where they caused the voltage distortion measured at the machine shop service.

The utility, when notified about the voltage distortion problem, agreed to install a separate transformer serving only the machine shop. The Fluke 43B showed voltage distortion on the new transformer was only 3.3 % — less than half of the previous value.
