Network hub failure

Application Note

Power Quality Case Study

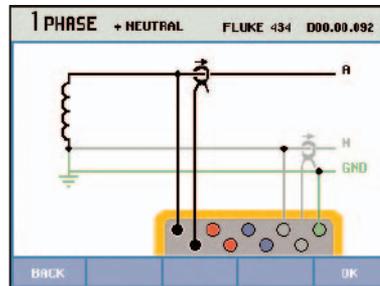
Fig. 1 View configuration screen

After connecting his Fluke 434 to the branch circuit supplying the hub equipment, he checked the View Config screen (Fig. 1) diagram to verify proper connections. From there, he pushed the Scope button and saw an abnormally high neutral waveform. (Fig. 2) He checked the numeric values at the top of the screen and saw that neutral voltage was in fact incredibly high, at 23 volts, indicating a possible neutral-ground issue. He saved that screen for customer documentation.

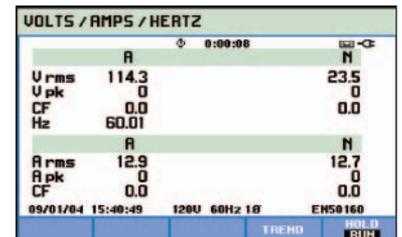
Fig. 3 Voltage level check

Just to be sure, he switched to the V-A-Hz screen (Fig. 3) and checked the voltage level again. He got the same results. Following standard power quality practices, he began looking for a grounding problem at the branch circuit, since that was the next step in the wiring path.

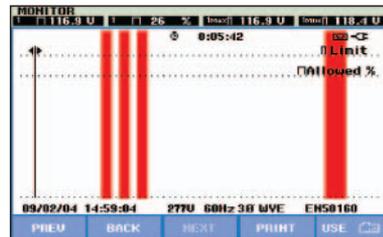
Fig. 4 Set recording time

He pressed the Monitor button (Fig. 4) and set the recording time for 24 hours. After the first 15 minutes, he pushed the trend button while continuing to record in the background. (Fig. 5) Shortly into the cycle he saw a dip in the line.
