Finding a Power Quality needle

In a 30-mile haystack

Application Note

Power
Quality
Case
Study

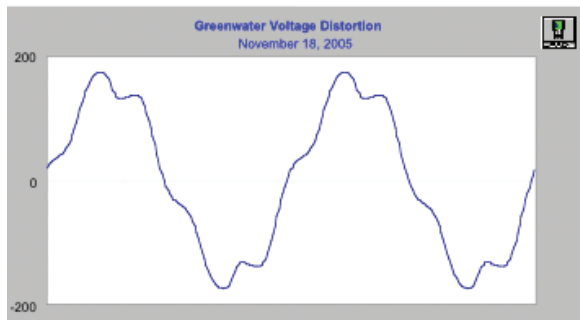
On the way up to the ski area, DeCrausaz took a measurement with a Fluke 41B power meter at an outside receptacle of a convenience store in Greenwater. Greenwater is a bedroom community on the main power line feed from Enumclaw to Crystal Mountain. The voltage distortion was huge at 14 % shown below.

Greenwater convenience store 120 vac receptacle. All lifts at Crystal Mountain running. Filters off.

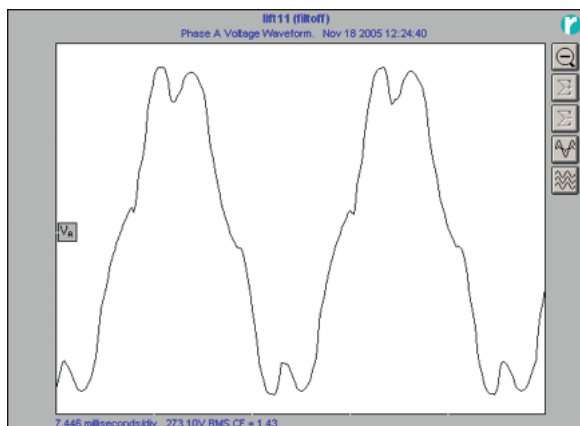
When first on-site, DeCrausaz and McConnell made an attempt to measure the voltage and current of the problem power filters with the lifts running, it turned out this was impossible due to the possibility of damaging the filter. The filter would have to absorb the entire harmonic current of the utility system plus the harmonic current generated by the dc drive of the lift. Note below the voltage waveform at Lift 11 with all the lifts running and NO filters on line.

Lift 11 with all lifts running and no filters on line.

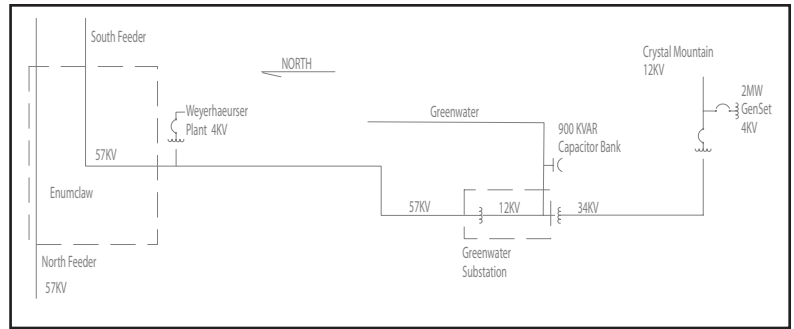
After further investigation, a 900 kvar-capacitor bank was located on a pole near the Greenwater substation on the 12 kv line servicing the town. The capacitors had been switched online at the end of April for a still undetermined reason. During the summer the C-phase fuse had blown several times and been replaced. The C-phase fuse was out and hanging down when the capacitor bank was located. At that point, the utility removed the remaining two fuses and said it planned to remove the capacitor bank from the pole so that it couldn't be inadvertently energized.

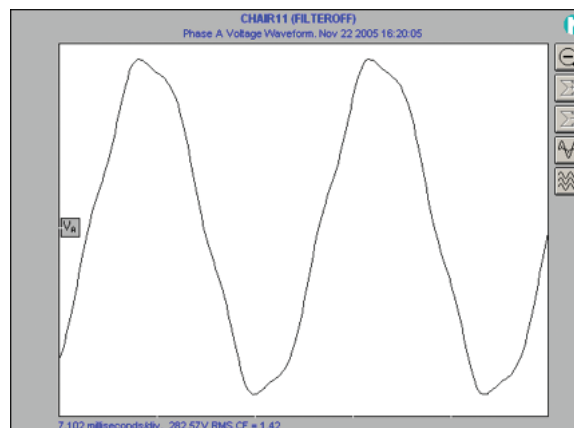
Later at the ski area, the following voltage waveform was recorded at Lift 11 with the mountain shutdown for the evening. Note the amount of distortion still on the utility system.

Lift 11 off. Filter off. All other lifts off. Utility caps off.

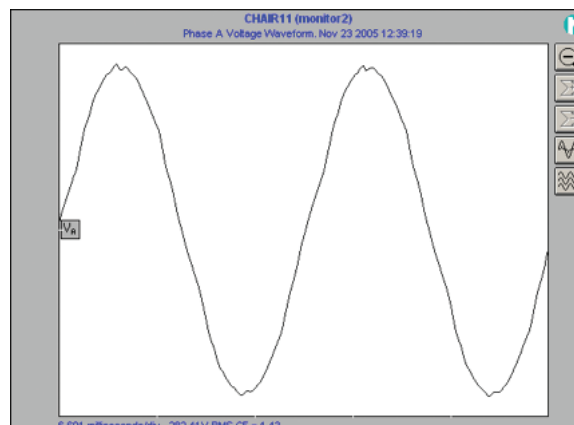
That evening at the ski area, all the power filters were put on-line and measurements taken to prove their health. The voltage distortion at the area was reduced to 3.1 % THD. The next day, technicians turned on all of the lifts with all four filters and all of the pumping stations and conveyors online. The voltage waveform below is at Lift 11 with all the lifts and filters on line.

Lift 11 on, filter-3 steps. Lift 10 on, filter-3 steps. Lift 9 on, filter-3 steps. Lift 3 on, filter-2 steps. All other lifts running.
