Instant power replay solves a breaker trip

Testing Functions Case Study

Application Note

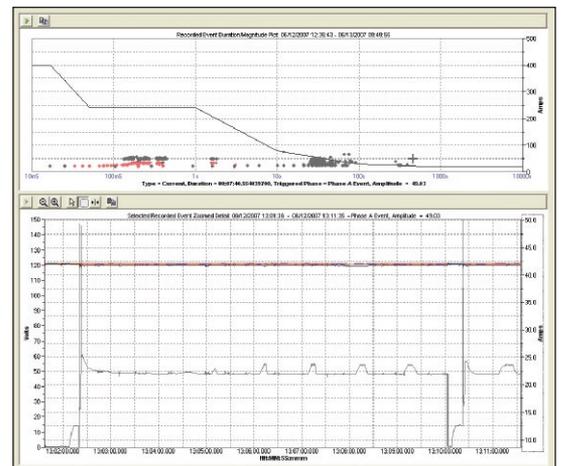
Figure 1. Current event view, top level events

The current event view shows several events outside the 20 A breaker tolerance curve. The longest event is shown in Figure 1.

The event exhibits a double initial current surge, followed by a sustained current over 20 amps. Although the circuit breaker did not trip during this event, its rating was exceeded and it would be likely to trip occasionally under similar conditions. These conditions are frequent during use of the temperature chamber, as can be seen in the graph above, where this event is immediately followed by another similar event whose beginning can be seen at the right side.

The power feed to the second floor is robust. The nuisance tripping is most certainly due to temporary overload of a standard 20 amp appliance branch circuit from using an industrial temperature chamber on the circuit. The temperature chamber should be connected to a dedicated branch circuit, sized to meet the requirements of the chamber, minimum 20 amps.

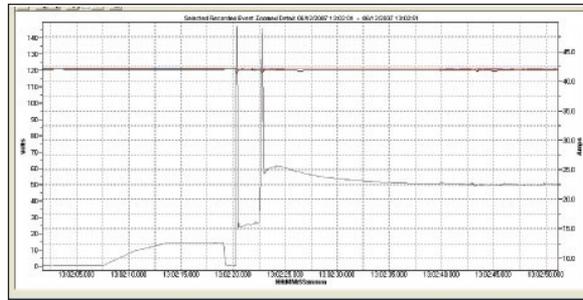
Figure 2. Compressor activity

Zooming into the initial region of the event in Figure 2, we see the turn-on loads of the temperature chamber's dual compressor system. The first compressor turns on with a large initial surge, followed by the secondary compressor surge. This load profile clearly identifies the temperature chamber as the cause of the overload.

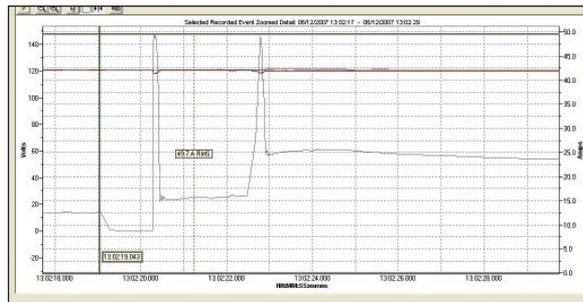
Figure 3. Load evaluation

Temperature chamber peak current is 49.7 amps. In Figure 3, the sustained load is near 25 amps.

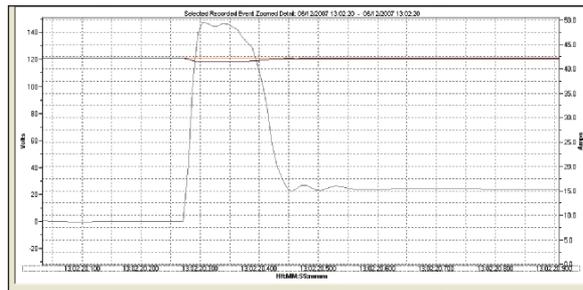
Figure 4. Interpreting voltage drop

We can zoom in further, in Figure 4, to see even more detailed resolution of this initial current surge. Note that the phase A voltage sags during this current surge, but the voltage drop is small, indicating that the power feed at the sub-panel is very stiff, and can accommodate substantial demand.
