# Troubleshooting premature motor failures

A case of excessive ground currents

Application Note

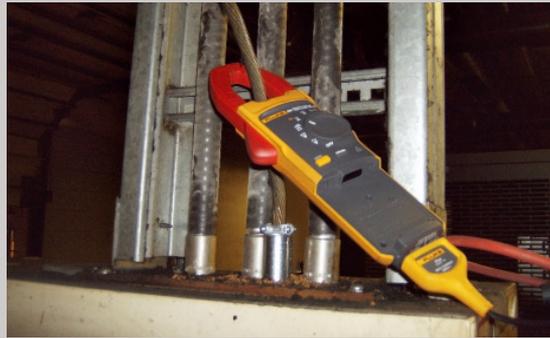
However, when they measured the ground currents flowing from each air compressor through the cable trays and through the metal air pipe, using the Fluke 381, they found more bad news. “Those measurements revealed multiple ground paths with a significant amount of current flowing from each compressor,” says Copp. “We used a Fluke ScopeMeter® 190-204 with four Rogowski coil current transducers to measure the magnitude and phase of the components of the ground currents that were flowing in the conductors and the adjacent cable tray. It became clear that some inductive effects were contributing to the ground current and that these currents might contribute to the voltage unbalance on the subservice.”

Using the Fluke 381 clamp meter, technicians measured a significant amount of ground current flowing from each air compressor. Photo courtesy of Linamar Corporation

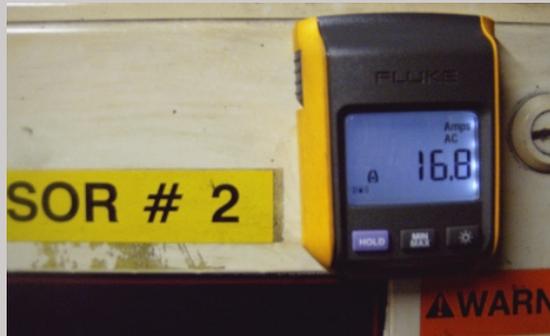
The Fluke 381 clamp meter's remote display attached to compressor #2 provided easy monitoring from several feet away. Photo courtesy of Linamar Corporation

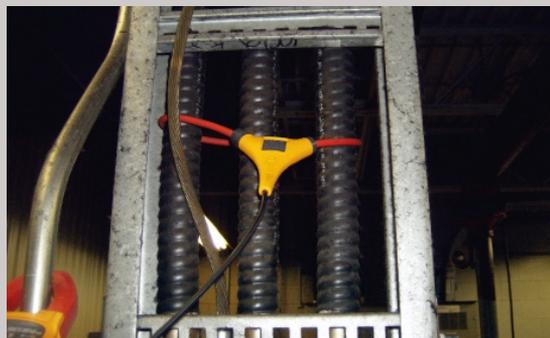
Copp and his team started their investigation with the compressor motors using a Fluke 381 Clamp Meter with iFlex™ to measure voltages and currents. "We found that there was a very small unbalance—maybe 1 percent to 2 percent—in the motor voltage but almost a 10 percent unbalance in the motor current, which could cause significant overheating," says Copp.

Linamar technicians clamped the iFlex™ flexible current probe around the three feeder cables at each compressor to measure phase current unbalances. Photo courtesy of Linamar Corporation

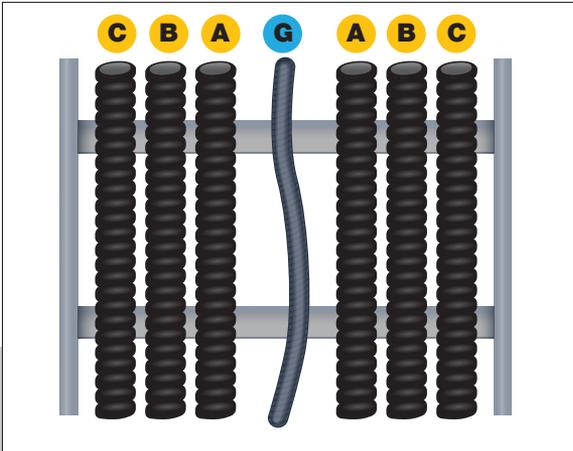
In the original cable tray configuration for the subservice feed powering the three compressors, the grounding conductor was located between two parallel three-phase runs of conductor cables. This created an interaction between the ground conductor and the phase conductor magnetic fields, which caused ground current to flow.

Based on the tests conducted during the shut-down, the ASG team concluded that the problem stemmed from the arrangement of the conductors between the main service and the 1200 A subservice. “We believed that the bonding conductor was placed in the wrong physical location in the tray, resulting in an interaction between the ground conductor and the phase conductor magnetic fields, which in turn caused ground current to flow,” says Copp. “The ground conductor was placed according to best practices from cable manufacturers and the NEC/CEC codes, but this investigation suggests that those practices may need to be reexamined.”

Through further testing, the ASG team and their counterparts at Camtac hypothesized that moving the ground conductor close to the side rail of the cable tray would help mitigate the induced ground currents. But that would require shutting down power to the compressor feeders. So once again they waited for a suitable window when production could be suspended for a few hours. A few months later that opportunity appeared and the Camtac engineers took care of the relocation.

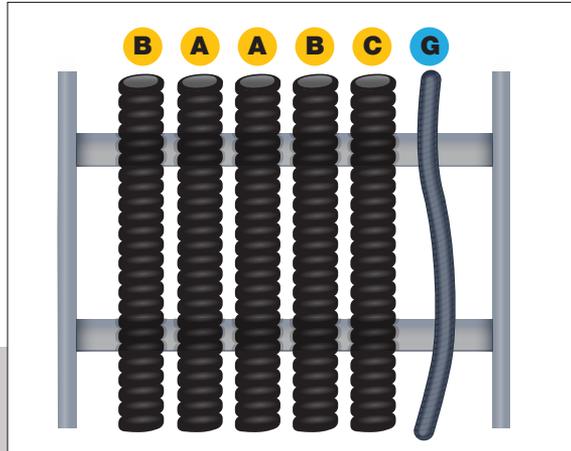
Linamar technicians found a significant reduction in ground current after relocating the ground conductor (G) to the side of the cable tray.

Grounding and leakage currents		
Equipment	Current	
	Before relocation	After relocation
Grounding conductor	160 A	45 A
Cable tray side rail	70 A	20 A
