# Electrical panel overheating for no apparent reason?

## Application Note

### Sometimes replacement is the only way to go

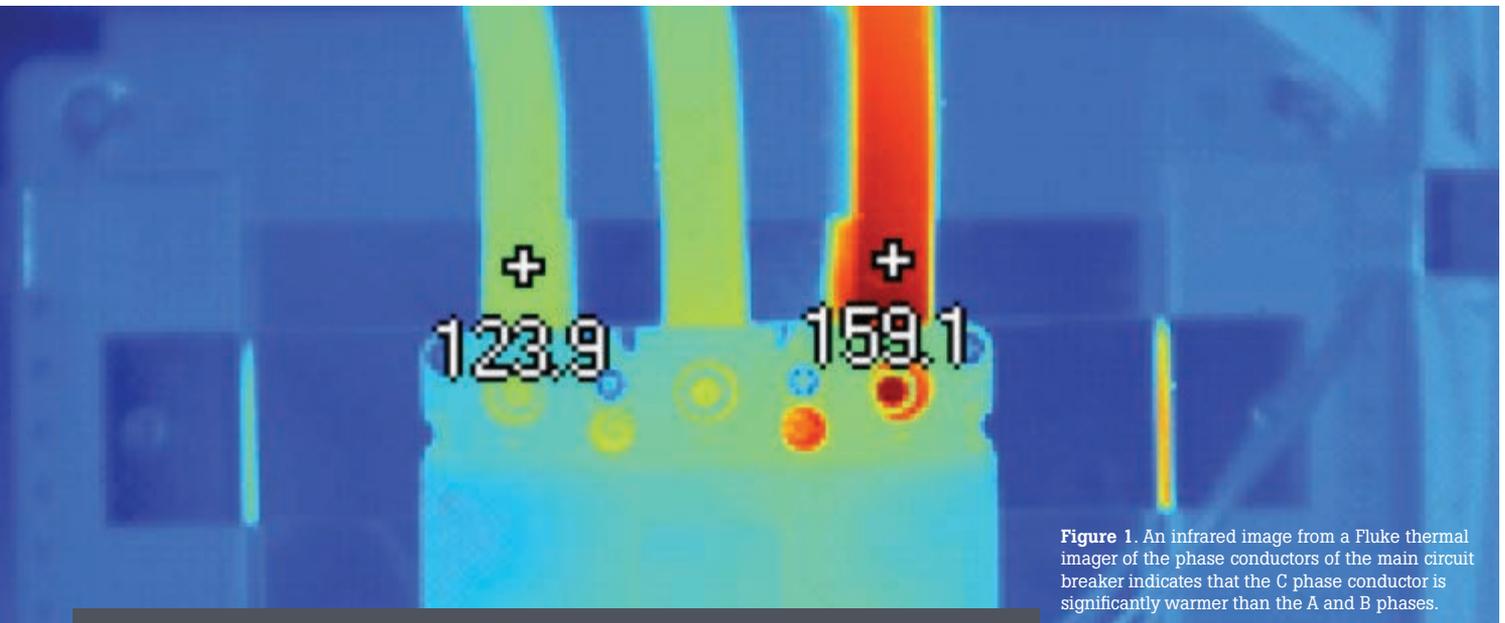
**Figure 1.** An infrared image from a Fluke thermal imager of the phase conductors of the main circuit breaker indicates that the C phase conductor is significantly warmer than the A and B phases.

The voltages measured across the "A" and "B" phases were well within range. However, when he got to the "C" phase the 137 mV measurement made it pretty obvious where the heat was coming from. Since the problem still didn't warrant a shutdown, the electrician brought out his Fluke thermal imager, which not surprisingly showed the C phase was significantly warmer than the A and B phases (see Figure 1).

At the top of the circuit breaker the wire was very warm and grew cooler as the camera moved farther way from the circuit breaker. This indicated that the problem was most likely at the lug or where the lug connects to the circuit breaker.

Because the troubleshooting isolated the location of the problem but didn't pinpoint the exact cause, the customer and electrical consultants decided to replace the entire guts of the panel—including all of the circuit breakers—and pull new feeder conductors. "We're going to that extent because the cost of downtime and criticality of the system are so significant that the customer wants it fixed. They don't want to have to arrange another outage anytime soon," the electrician explains.

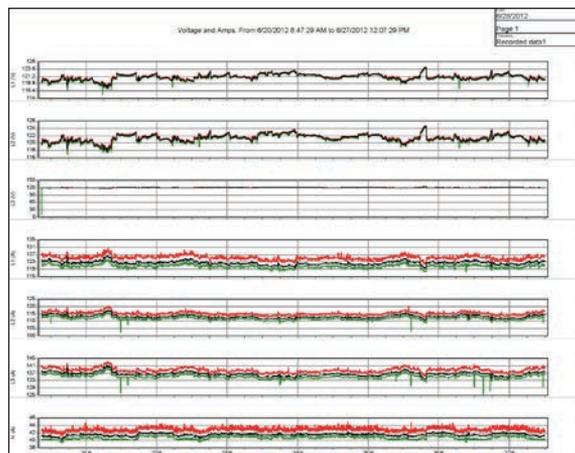
Figure 2. A week-long recording of the current on the conductors feeding the main circuit breaker showed no anomalies indicating that the problem was at the lug, or where the lug connects to the circuit breaker.

Before leaving the site, the electrician attached the Fluke 1735 Three-Phase Power Logger to the conductors feeding the 225 A main circuit breaker and left it for a week to measure current. That didn't show any anomalies with the current (see Figure 2).

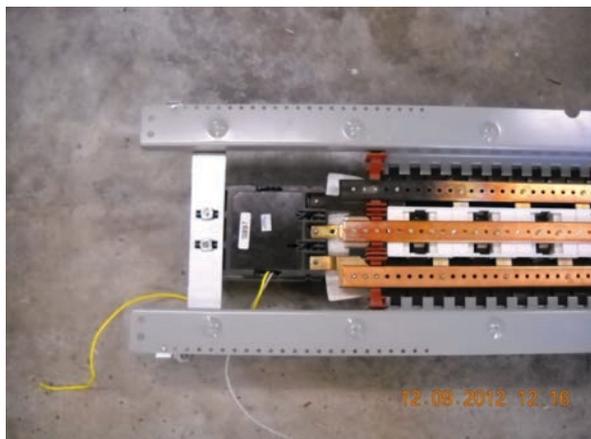
With a clean bill of health on the new panel, the consultants went to work. They de-energized the old panel, disconnected all the conductors, and removed the guts. At that point they did a visual examination and found signs of severe overheating at the point where the A phase bus connects to the main circuit breaker (see Figure 3).

**Figure 3.** The “A” phase bus shows signs of severe overheating at the point where it connects to the main circuit breaker.

Next the electricians installed new interior phase bussing, branch circuit breakers, main circuit breaker, and phase conductors, and reconnected all the conductors. After re-energizing the panel, they tested it to verify that the new panel was working as specified. Using the Fluke 1587 Insulation Multimeter they took a series of voltage measurements including the voltage drop across the line and load side of the main circuit breaker, which showed the following voltage drops:

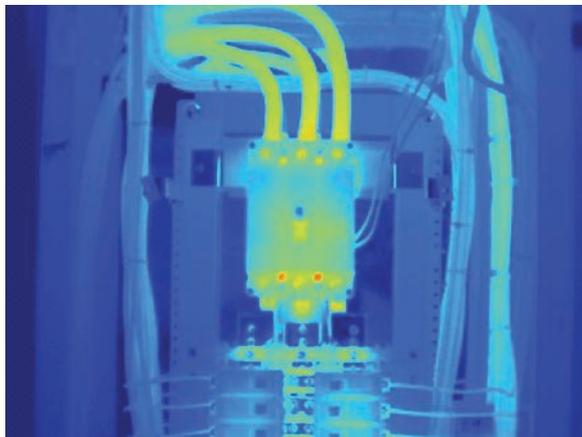
Finally, they scanned the phase conductors of the main circuit breaker under load using a Fluke thermal imager. The scan showed balanced loads across all three phases (see Figure 4).

**Figure 4.** Thermal image of the phase conductors of the main circuit breaker after panel replacement shows balanced loads across all three phases.

Although the measurements showed that the new panel is functioning within the 80 percent load rating, the consultants expect it to approach the 80 percent threshold soon. As the load increases so does the heat, so they recommended that the customer monitor the situation and plan to install a new power feeder in the not-too-distant future.
