Fluke Inspection Services, Inc.

Prepared for:

Mr. & Mrs. Property Owner
123 Residential Street
Everett, WA 55427

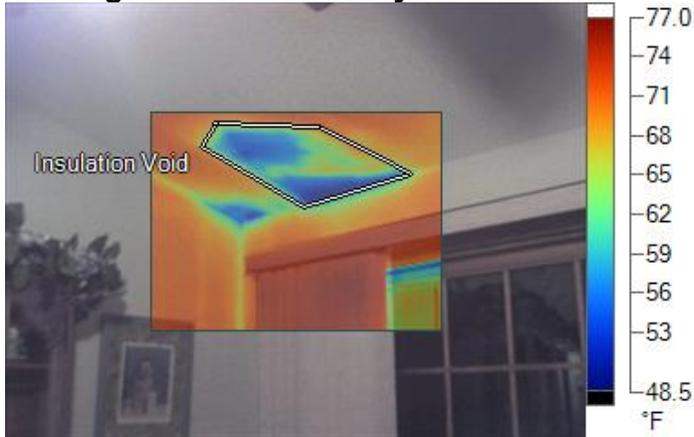
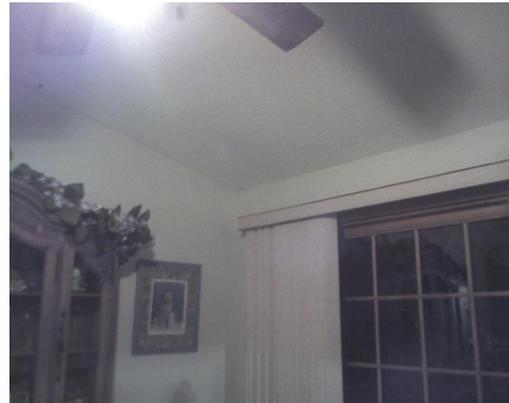
Missing Insulation - Family Room

Missing insulation as indicated by the blue color on the image. Due to the vaulted ceiling, the cost of making this repair will likely outweigh the energy savings.

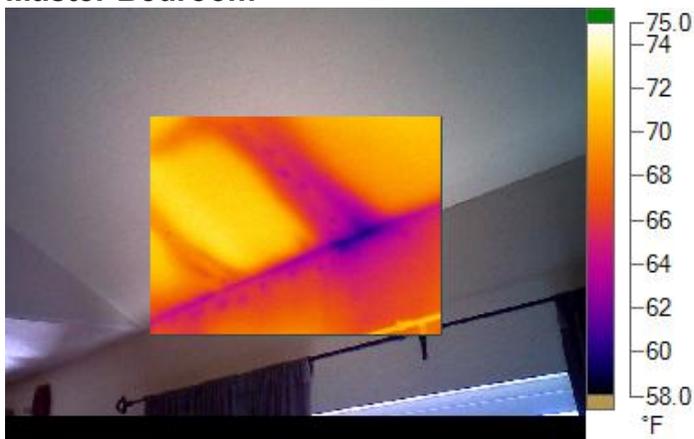
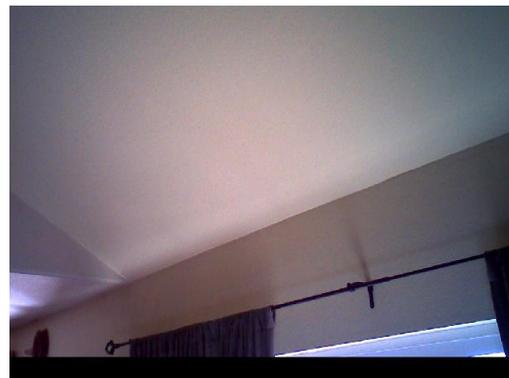
Master Bedroom

Moisture detected above South-facing window with thermal imager and confirmed with moisture meter. Determining source of leak requires further investigation, but is likely to be caused by a roof defect.

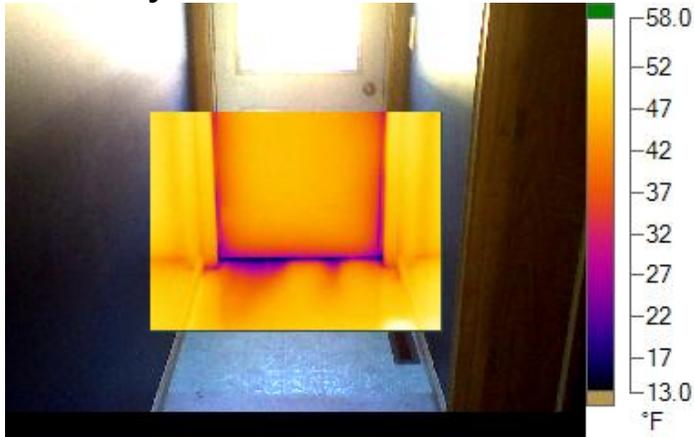
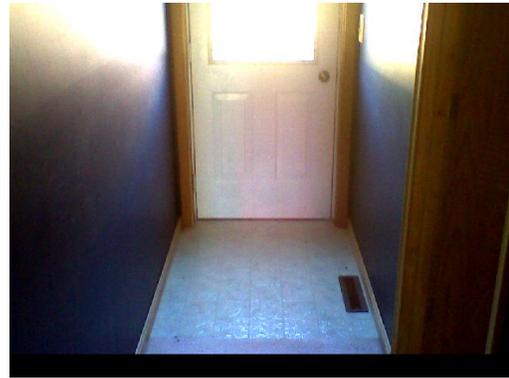
Rear Entry Door

Significant air leak detected. Recommend replacing weather stripping.

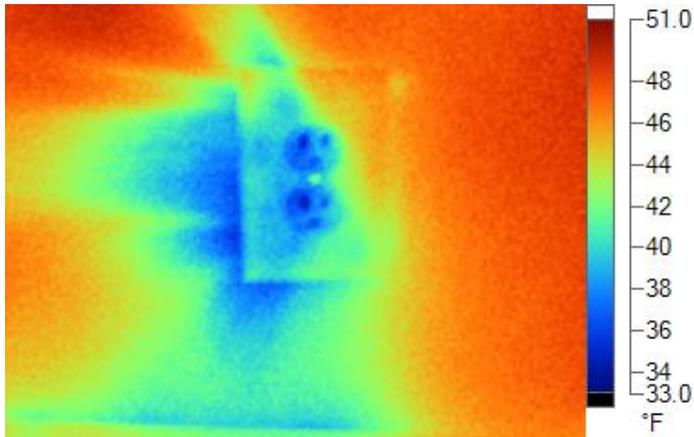
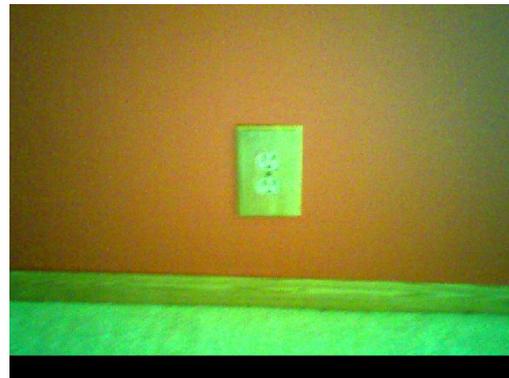
Electrical Outlet - Kitchen

Air leak detected on electrical outlet on exterior wall in kitchen. Recommend air sealing with foam, caulk or foam gasket.
