The malfunctioning medical machine

Application Note

Power Quality Case Study

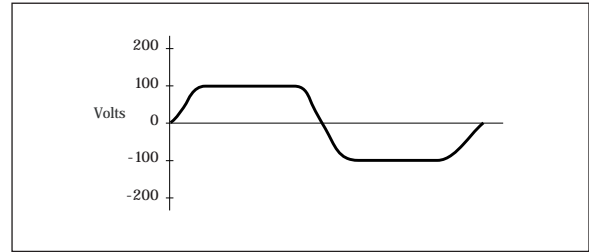
waves. The contractor connected his Fluke 43B and displayed the voltage waveform. The display showed that the waveform (simulated in Fig. 1) was severely clipped at the top – making it more like a square wave than a sine wave. The peak value measured only 135 V, rather than the expected 162 V.

Fig. 1 Waveform of voltage supplying the medical machine (simulated)

True-rms instruments will give correct, but lower readings than average-responding instruments on square waves or waveforms that look like square

Since the medical machine’s internal circuits operated on low voltage dc, the internal power supply would have a diode/capacitor input circuit that required a certain minimum peak voltage for proper operation. The nameplate on the medical machine showed the machine needed a supply

voltage between 100 and 135 V rms ac. The engineers who designed the machine and specified the nameplate assumed the supply voltage would be a sine wave, so the minimum peak would be 141 V peak (100 x 1.41). Since the measured value of the peak input voltage was only 135 V, the machine was running on a peak voltage that was already 6 V below the absolute minimum required. When the fan was turned on, the surge current drawn by the fan motor further reduced the voltage to a point where the power supply of the machine went out of regulation. This is what caused the machine to reset.

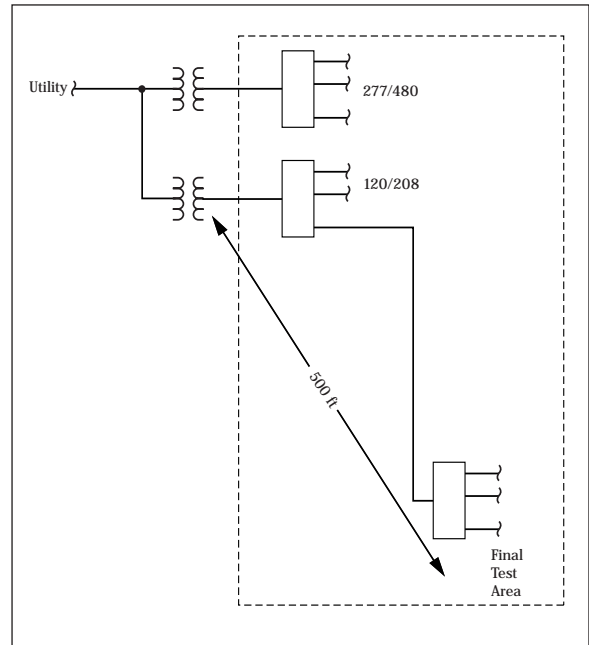
The contractor then drew a one-line diagram of the system. The one-line showed that the transformer supplying the test area was at the opposite end of the building – almost 500 feet away (see Fig. 2). The majority of the loads on that transformer were non-linear, and they were drawing high peak currents at the peak of the voltage. The combination of high peak currents and high impedance of the long run combined to produce severe voltage clipping at the end of the circuit – right where the test area was.

Fig. 2 Partial one-line diagram of the high-tech manufacturing plant

The problem of voltage peak clipping (flat-topping) is common in high-tech buildings. Many of the buildings now in use were not designed to handle the vast array of computers and non-linear loads so typical today.

In this case, extensive rewiring would be necessary to reduce the voltage drop between the transformer and the load. An alternative would be to move the most sensitive loads closer to the transformer.
