# Three phase motor failure

## Application Note

### Power Quality Case Study

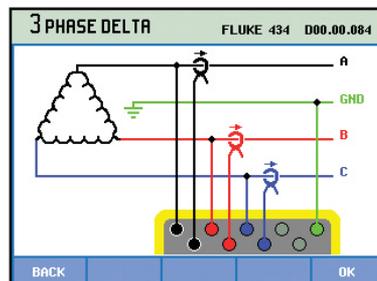
Fig. 1 Three phase Delta

The consultant connected his Fluke 434 three-phase handheld power quality analyzer to the circuit supplying energy to the motor and pushed the View Config button. The diagram confirmed that his connections were proper and that the power type was three-phase Delta (Fig. 1).

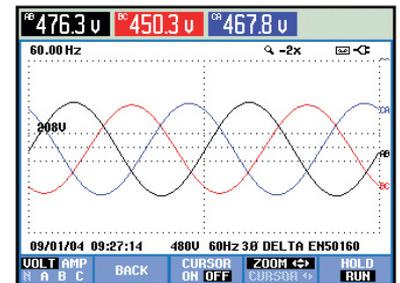
Fig. 2 Unbalance voltage wave

From there, he pushed the Scope button and looked at waveforms and numeric values for all three phases. Judging by the differences between the magnitudes at the top of the screen, there appeared to be a balance problem between the phases (Fig. 2).

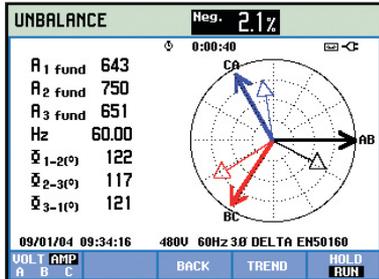
Fig. 4 Unbalanced phaser amp

Switching to the Unbalance screen, he checked the voltage and current values as well as the phase diagram, to see if the motor was operating within acceptable limits (Fig. 4-6).

were connected to the same phase. That last new equipment installation caused such a significant power system voltage unbalance that it created a current unbalance at the motor, increasing the operating temperature of the conductors and motor windings to beyond the limits.

To resolve the situation, the consultant balanced the internal single-phase loads between the three phases, reducing the overall voltage unbalance and consequently, the current unbalance at the motor. This also reduced the elevated phase current value and operating temperature at the motor.

From his unbalance measurements, he could see that an unbalance was causing an excessively large phase current value. He checked the motor specifications and confirmed that phase current exceeded the motor's FLA (Full Load Amperage) rating. Looking at the data for all three phases, he traced the current unbalance to excessive loading on one voltage phase.

The consultant traced the voltage unbalance to a set of equipment installed three years ago. It turned out that all of the internal single-phase loads

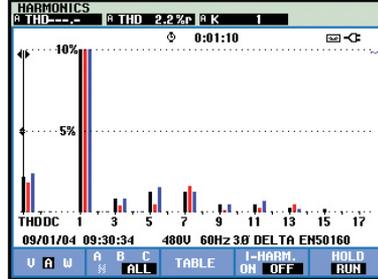
Fig. 7 Harmonics

Lastly, to cover his bases, he selected Harmonics from the menu to make sure frequencies weren't contributing to the problem (Fig. 7 & 8).
