## Motor and drive tests keep lift station running during upgrade

### Application Note

### Testing Functions Case Study

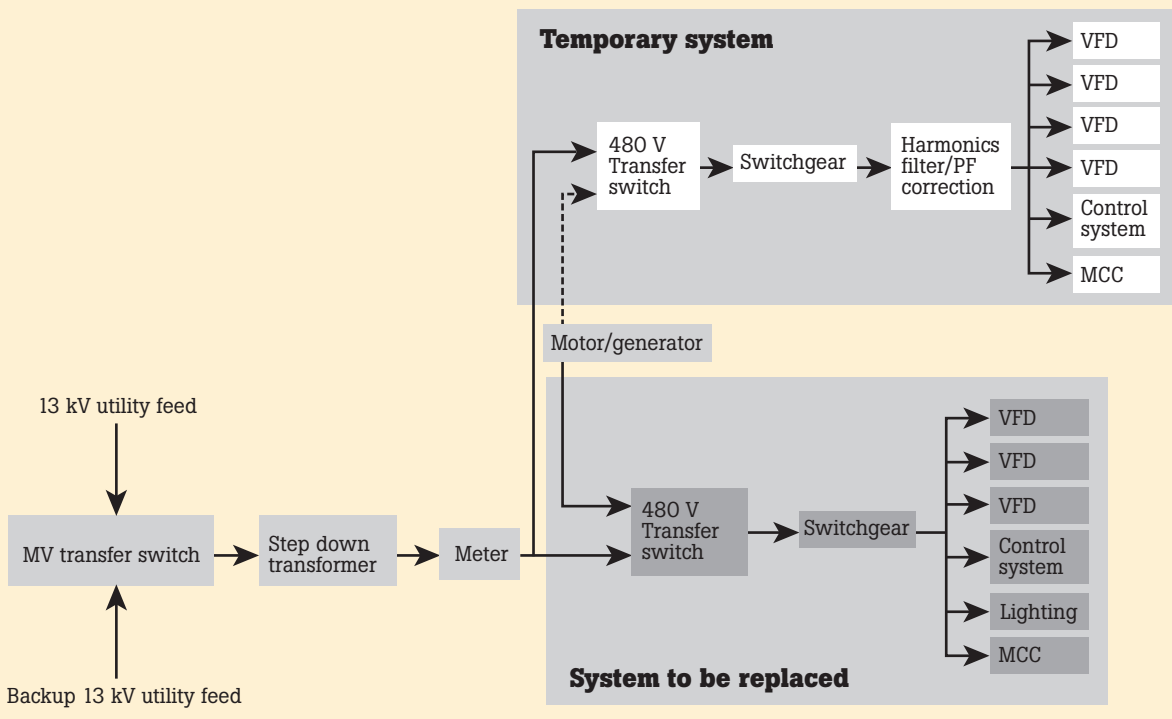
Key elements of the duplicate electrical system.

Valley Electric Company of Everett, WA was awarded the contract to retrofit the electrical systems in the lift station. The station runs 24 hours a day, seven days a week, so bringing it down was not an option. So, Valley built a duplicate electrical system in a modular structure next to the pump house. The temporary system includes switchgear, MCC's, variable frequency drives, transfer switch, surge suppression, and harmonics and PF correction. The modular structure also houses a duplicate control system that will take input from existing sensors and control the pumps. After this temporary system is used for this pump station, the plan is to lift it by crane and move it onto the next retrofit.

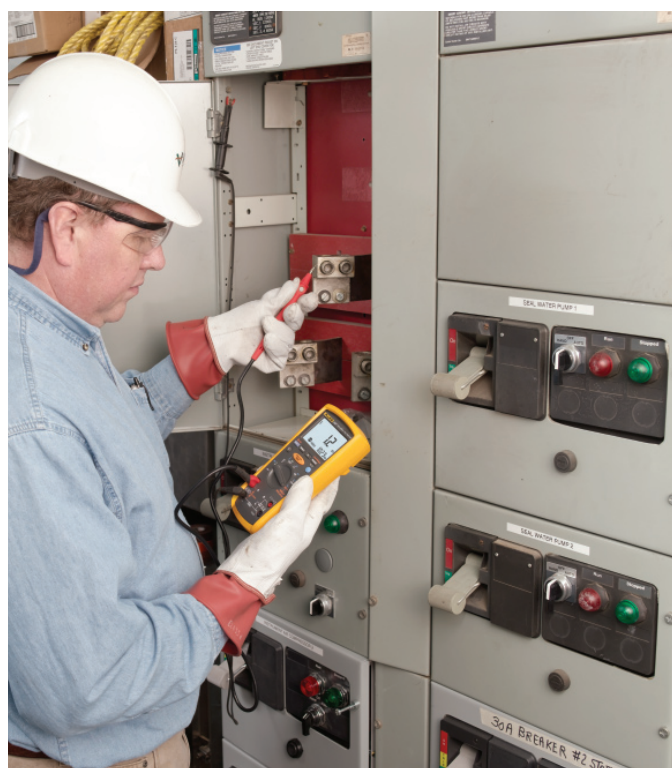
Steve Uhrich tests resistance of drive cabling.

Prior to connecting the new system to utility power, Uhrich and Glazier tested the incoming cabling and switchgear. The 1000 V insulation testing and continuity functions of the 1587 were used during this initial testing. They insulation-tested each of the conductors to ground and to each other. During this phase of testing they found that one of the phase conductors from the fused disconnect, feeding the temporary switchgear, had only 400 kΩ resistance to ground. It should have been at least in the megohms. They replaced the cable before proceeding.
