APPLICATION NOTE

Inspecting bearings

Applications for thermal imagers

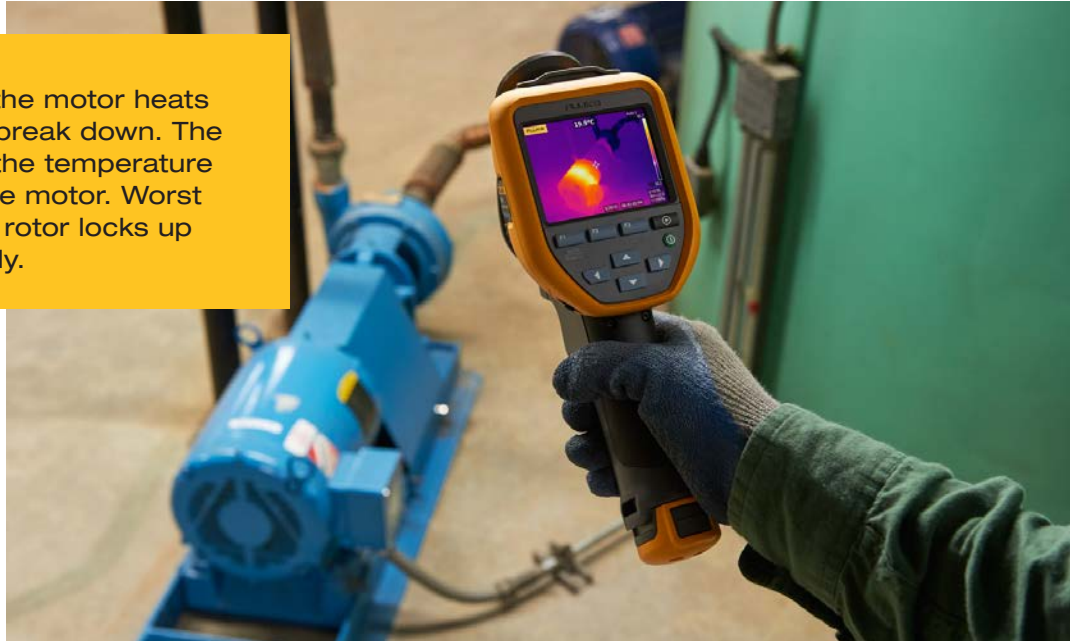
Problems with bearings are usually found by comparing the surface temperatures of similar bearings working under similar conditions. Overheating conditions appear as “hot spots” within an infrared image and are usually found by comparing

similar equipment. In checking motor bearings, this procedure entails comparing end bell to end bell (for motors and bearings of the same type) or stator to end bell temperatures.
