Performing power quality studies and troubleshooting loads

Application Note

Field Applications Case Study

Tool: Fluke 1735 Three-Phase Power Logger

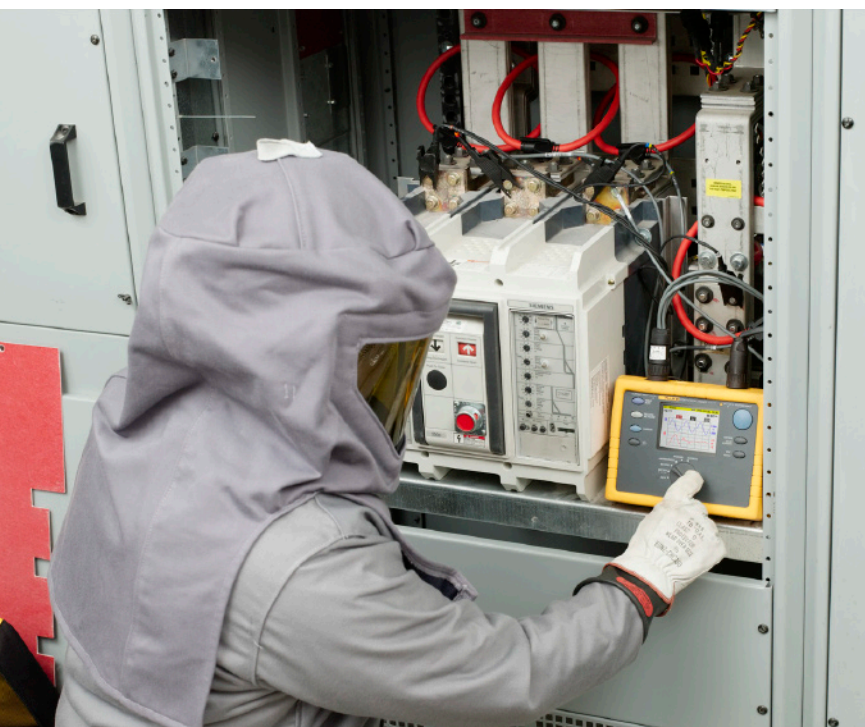
McArthur obtained a Fluke 1735 Power Logger and put it on the main transformer at the paperboard plant. He then turned off the suspect die cutter and sampled the electrical environment. With the die cutter not running, the second and fourth harmonics were essentially nonexistent. However, when plant personnel turned the machine on, the second and fourth harmonics went from almost zero amps to between six and 13 amps.

"We thought that would take care of the issue," McArthur says, "but when we started looking at the main service scan, we saw that we still had just about the same amplitude for dc current, indicated by the second and fourth harmonics. So, we had to isolate another machine as the source of the additional dc."

“That proved right then and there that this machine was our culprit,” McArthur explains. “We needed to have its drive system brought up to date using today’s technology. We had to get rid of those second and fourth harmonics. We knew that once those were gone the transformer would perform the way that it should. And that’s what happened.”
