## Thermal imaging paving the way for lower road maintenance costs

### Application Note

#### Testing Functions Case Study

**Inspections:** Asphalt temperature differences pre, during, and post application

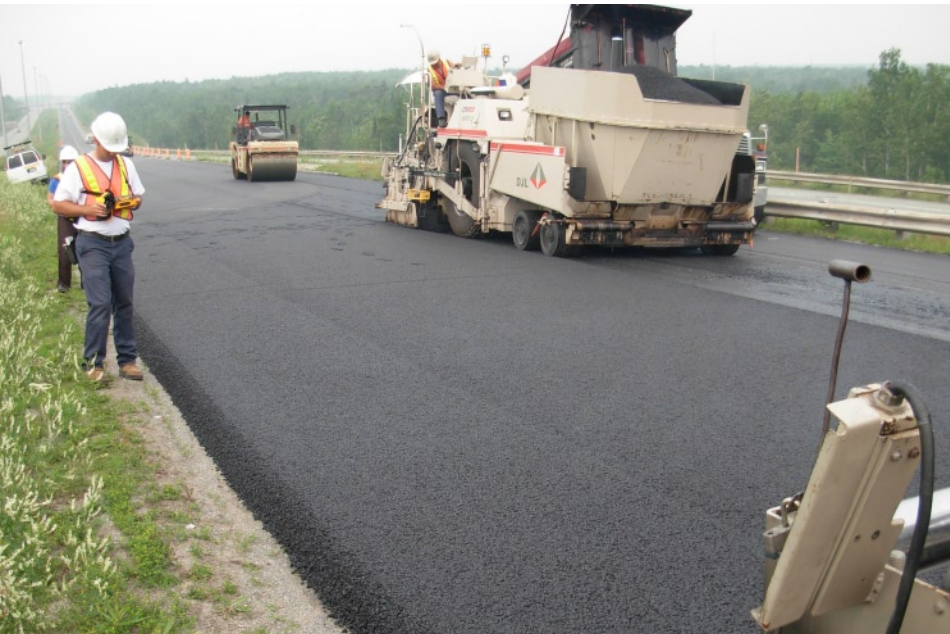
Taking asphalt temperatures during application.
