# Using thermography to reduce residential energy use

## Application Note

### Testing Functions Case Study

**Tests:** Tracing temperature differences to detect air/duct leakage, insulation problems, and other AC inefficiencies

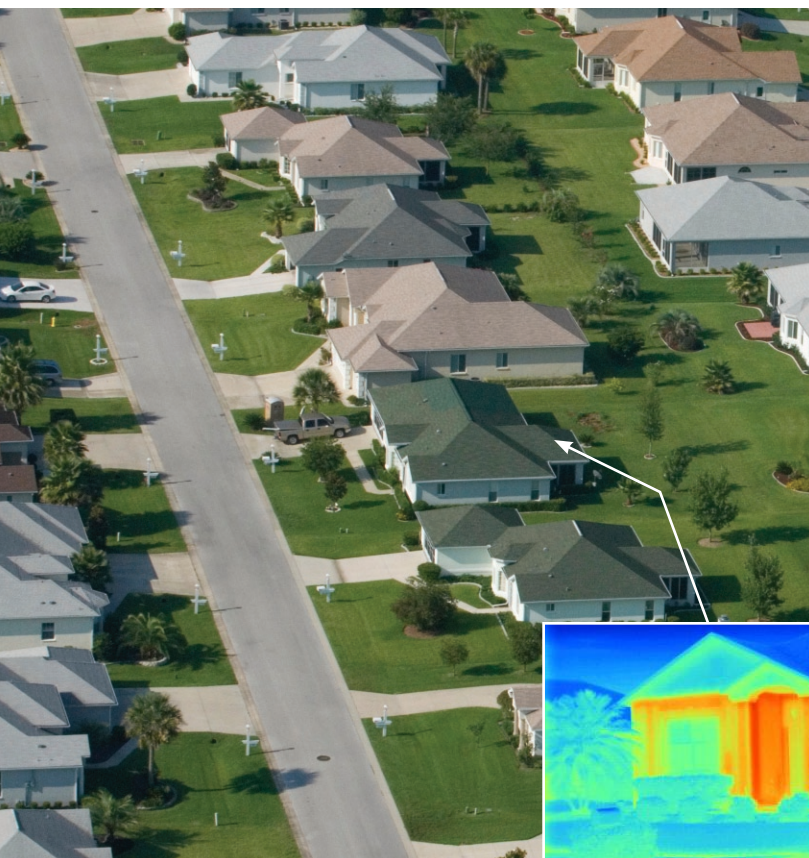
Carroll says that his thermal imager has increased the amount of business his company is securing. He says that in addition to using it to find air leaks in air-conditioning systems and building envelopes, he uses it for pinpointing water penetration. (Wet areas heat and cool at different rates than dry areas, and the imager will detect such areas.)

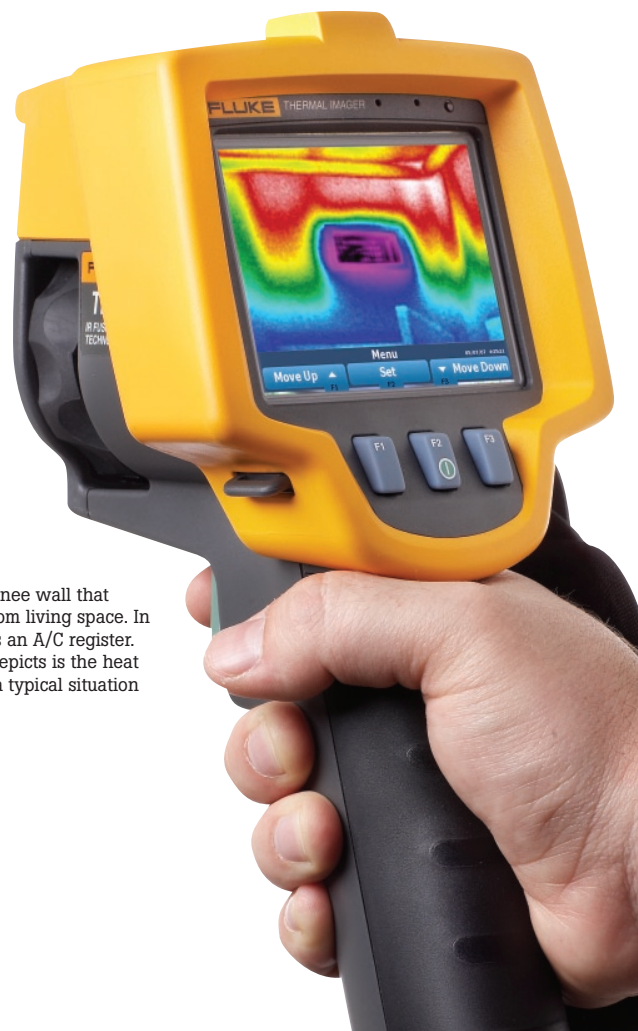
This is an IR image of a knee wall that separates an attic area from living space. In the center of the image is an A/C register. What the image vividly depicts is the heat gain to the duct system, a typical situation in attic duct systems.

To illustrate his point, Parker refers the reader to the thermal image on the camera below. Since attic duct systems don't work very well," he says, "we're working to find a way to get them inside the conditioned environment, insulate them better or bury them in insulation."

Parker and Carroll point out that their infrared cameras are useful in many other ways. For example, knee walls—vertical walls in attic spaces—are usually insulated, but often, because the insulation is installed vertically, it falls off. Missing insulation is very easy to find using an infrared camera. Another common problem detectable using thermography, besides missing insulation and unsealed A/C ducts, are uninsulated hot water pipes.
