## Electrical inspections using thermal imaging

### Application Note

By Jim White, Shermco Industries, for Fluke

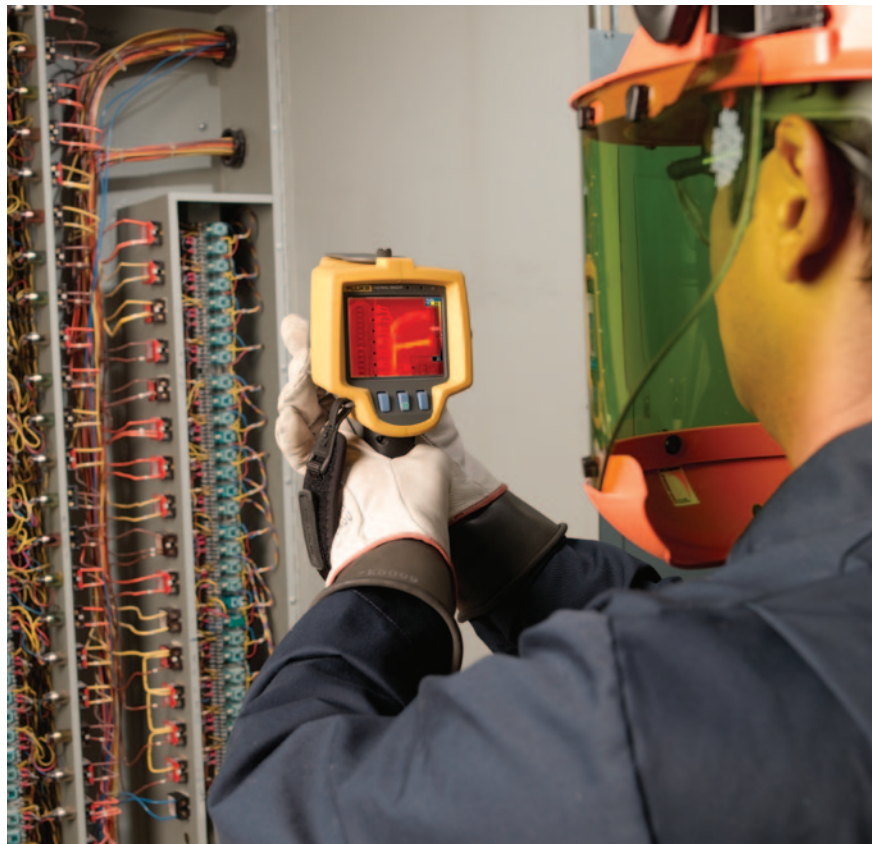
Inspection of lighting control circuits with a Fluke Ti25 Thermal Imager and appropriate PPE.

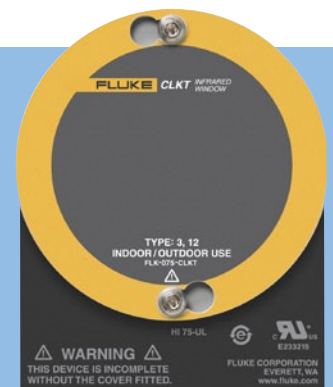
Infrared windows mount into panel doors and covers for switchgear, transformers, bus bars and other live electrical equipment, allowing thermal, ultraviolet, visual and fusion technologies to be used without exposing personnel to live equipment and easy compliance to NFPA 70E.

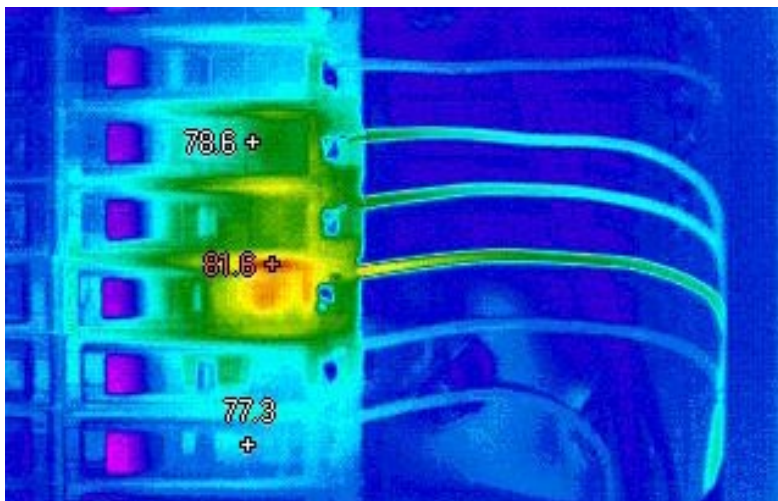
Figure 1. Thermal inspection of a molded-case circuit breaker terminal.

Infrared thermal inspections can find this type of defect reliably. Figure 1 is an example of a molded-case circuit breaker terminal that shows severe overheating. The tested spot is marked by a “cross” and the temperature difference is over 110 °C. NETA (the InterNational Electrical Testing Association) provides industry-accepted recommendations for action points for thermal imaging (see page 3).

When terminals are loose and under load, arcing can take place inside the threads, causing pitting that can't be seen by visual inspection. When the terminal set screw is retightened, it does not compress the conductor and only seats itself at the point where the damaged threads are. Even though the set screw is now tight, the conductor is still loose in the terminal and overheating continues.

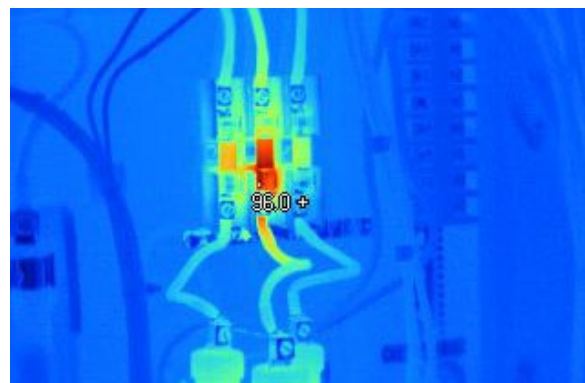
Figure 3. Improper contact pressure.

Figure 3 shows a switch with high contact resistance. Later inspection found that the operating mechanism was experiencing mechanical binding. This fairly common defect can sometime weld the contacts together (Figure 4). Both situations are extremely hazardous. An overheating contact assembly (Figure 3) could cause a fire or fail when opened or closed, and a welded contact (Figure 4) can't open. If the welded phase won't clear during fault conditions, it could result in an explosion. During normal operation, the welded phase would remain energized.
