APPLICATION NOTE

Inspect buildings with speed and precision

Using infrared to find air leaks, insulation issues and moisture

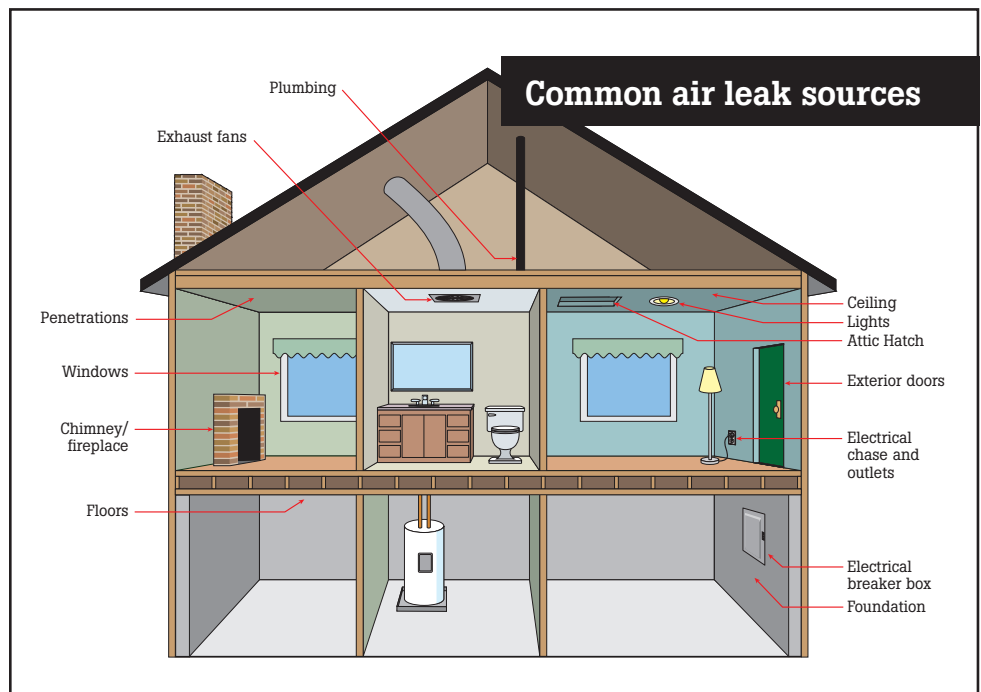
Heating and cooling the conditioned or living space accounts for almost 45 % of a typical home's energy use. Property owners can realize significant savings if proper measures are taken to control unwanted air leakage, as air leaks relate directly to heating and cooling costs. Figure 1 illustrates which areas in a home represent what percentage of air leakage.

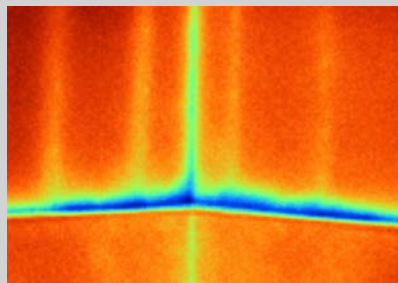
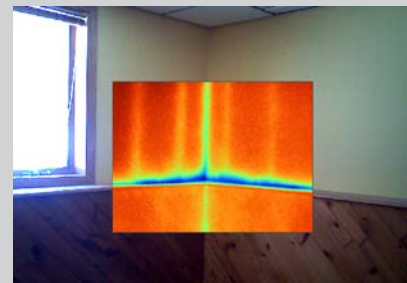
Picture-in-Picture, an IR-Fusion viewing mode, takes the guesswork out of re-locating problems by providing a frame of reference such as in this infrared image of an air leak at the point where an exterior wall meets the foundation.

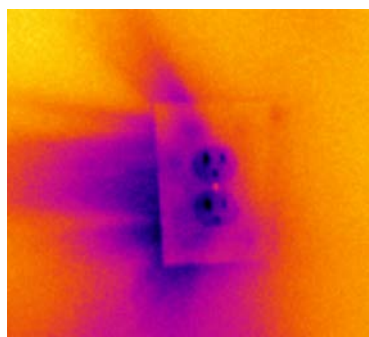
A blower door was used to increase the air flow around this outlet. Thermal imagers don't see the actual air moving but instead see the effect it has on a surface. Outlets and switches that are not properly sealed add to overall air leakage.

air rising in a home creates an area of low pressure at the lower levels and high pressure near the roof. These pressure differences force warm air to escape from the top and cold air to enter near the bottom. Other common areas of air leakage are highlighted in Figure 2.

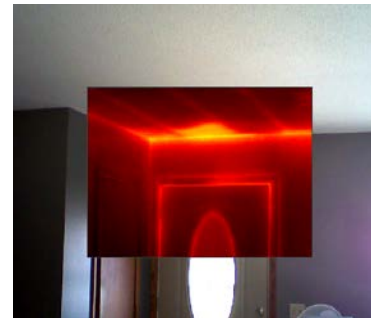
Recessed blown-in attic insulation

It's much easier to interpret findings if the type of insulation is known. Knowing the insulation type enables an auditor to prepare for issues commonly associated with certain insulation types. For example, blown-in insulation is notorious for settling over time.
