Thermal imaging helps make Energy Idea House a “zero hero”

Application Note

Testing Functions Case Study

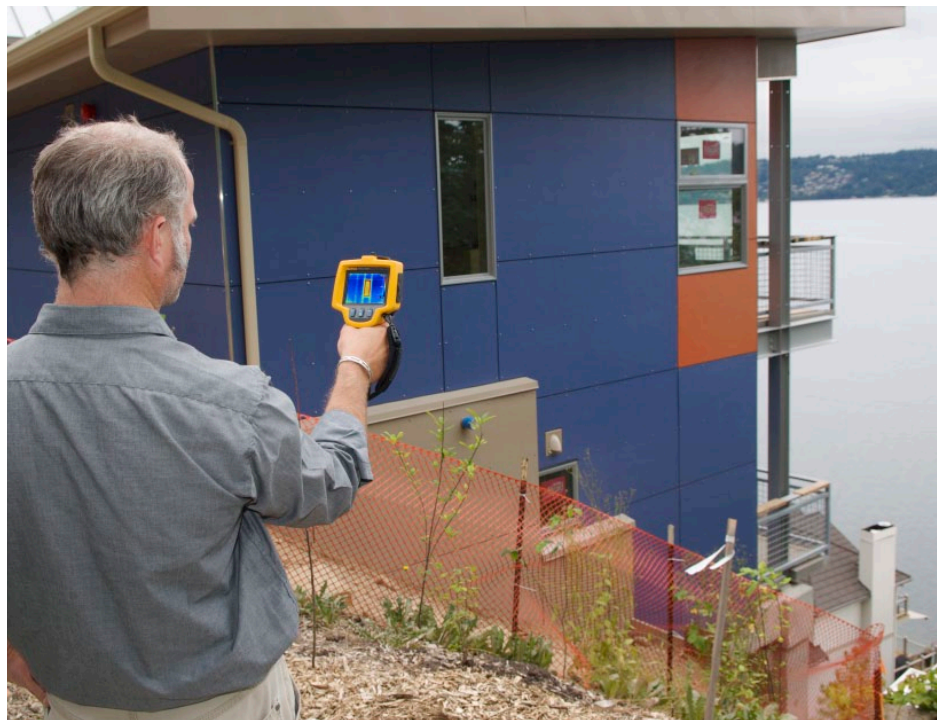
Infrared inspection of all external windows and doors can often show defects in installation or materials that contribute to energy loss.

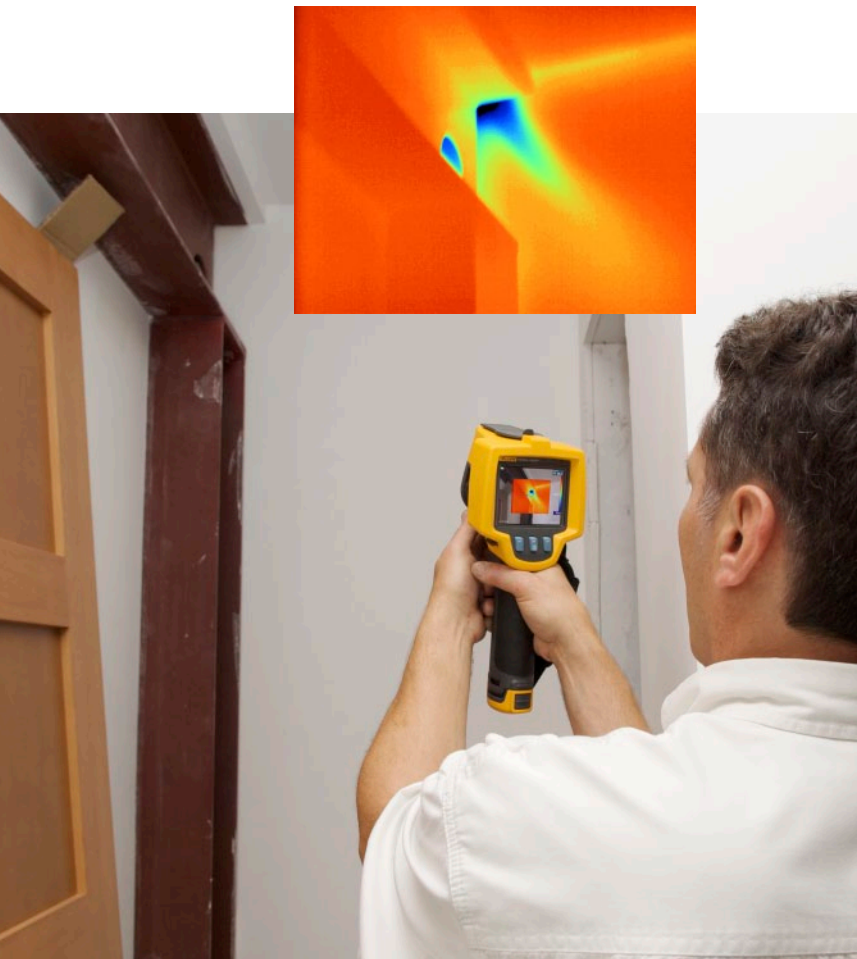
An unexpected area of air infiltration was found coming from behind a major support beam. This may have never been discovered without the use of the TiR32.

imagers revealed small leaks in door and window framing and caulking. Air was entering through a loft area electrical chase, from the southwest corner of a main floor, south wall steel support beam, and in an area between the main floor and lower ceiling. Stuart recorded and documented every cold spot to be followed up later and repaired.

An additional negative pressure test, a positive pressure test and a follow-up infrared inspection will be planned for later this year, once repairs and adjustments are made. After the repairs, Shirey Contracting is shooting for a new milestone—an air exchange rate of 1.5 or better.

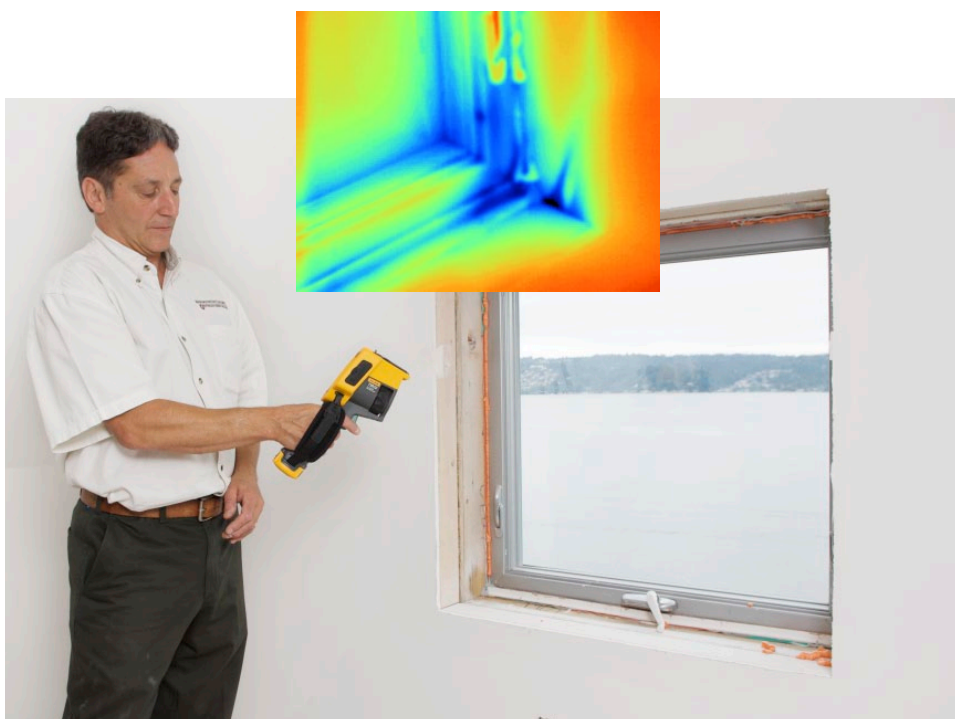
Inspecting all windows, doors and envelope penetrations from the inside of the house also yielded interesting information that helped to further increase the home’s energy efficiency.
