Measuring Motor Shaft Voltage and Bearing Currents with the Fluke 190 Series II ScopeMeter

Application Note

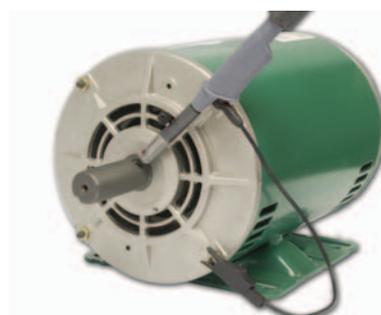
Measuring motor shaft voltage with an Aegis shaft voltage probe (Photo courtesy of Electro Static Technology).

Measuring the voltage of a rapidly spinning motor shaft can be difficult and dangerous. A shaft voltage probe helps to make shaft voltage measurements safer and more convenient by extending your reach, making the electrical connection to a motor shaft by means of a small conductive brush mounted on the VPS420-R voltage probe. The reference contact of the probe is connected to ground at the motor housing. For this study an i400s Current Probe was clamped on one of the cables between the VFD and the motor.

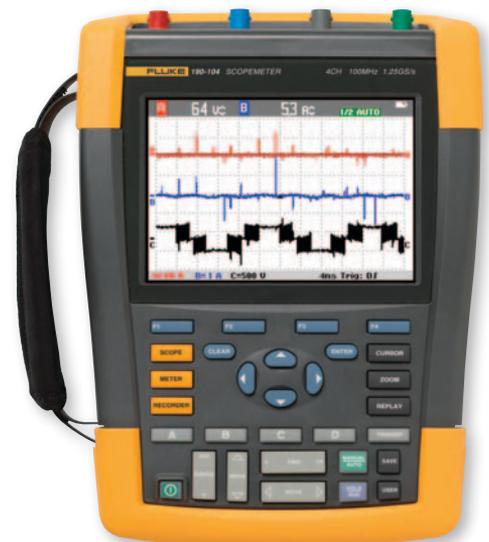
The Fluke 190 Series II ScopeMeter can simultaneously record and display four signals.

Shaft voltages and current spikes caused by the pulse-width-modulated output of motor drives can be exceedingly brief, often in the microsecond measurement range. The high bandwidth (up to 200 MHz) and fast sampling rate (up to 2.5 Gs/s) of the Fluke 190 Series II ScopeMeter® make it ideally suited for measuring rapidly changing voltages and currents—far superior to a digital

multimeter. Connect-and-View™ triggering automatically displays stable waveforms with virtually any signal, while ScopeRecord™ enables you to store waveforms in memory for later viewing. And because 190 Series II ScopeMeters can record and display four signals, you can simultaneously view both current and voltage from more than one source.

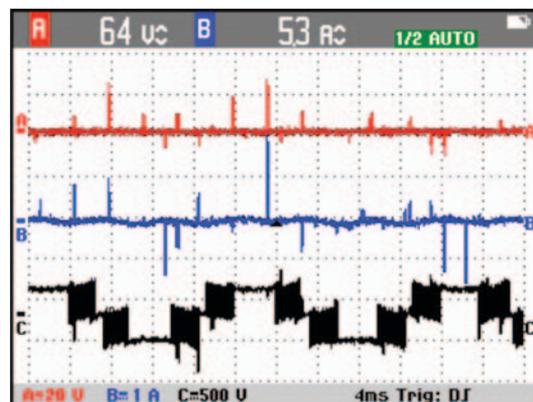
Figure 1. Shaft voltage, common-mode current, and motor drive output displayed on a Fluke 190 Series II ScopeMeter®.

All signals were measured on the T1, T2 and T3* of the Motor Drive. A typical measurement result is given in Figure 1 and can be explained as follows:

- Channel A (red trace) shows motor shaft voltage. Spikes can clearly be seen from the flashovers on the shaft through the bearing.
- Channel B (blue trace) shows current spikes on top of the current signal measured by the current clamp. The spikes give a clear indication of when a peak occurs, confirming a flash or spark. It is assumed that these currents pass through the bearing.

- Channel C (black trace) shows the output of the motor drive. The quality of this signal determines the efficiency of the motor. A fast rise time in conjunction with a high electrical capacity of the stator/rotor will contribute to the flashovers.

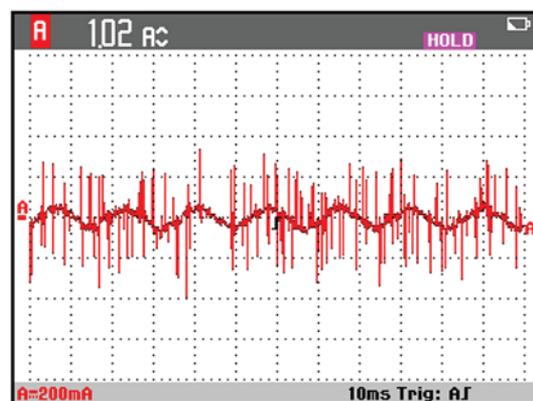
Figure 2. Sigma current.

In principle the total current through the T1, T2 and T3* line, referred to as Sigma current, should be equal to the current measured through the Protective Earth, referred to as PE current. In case there is a discrepancy, it is assumed that current is leaking through the bearing caused by parasitic capacitive coupling between the stator and rotor in combination with high frequency circulating currents. Both Sigma current and PE current are made visible on the screen captures as shown in Figure 2 and 3.

The erratic behavior of sparks can be seen on the captured screen of the Sigma current which is related to the bearing current.

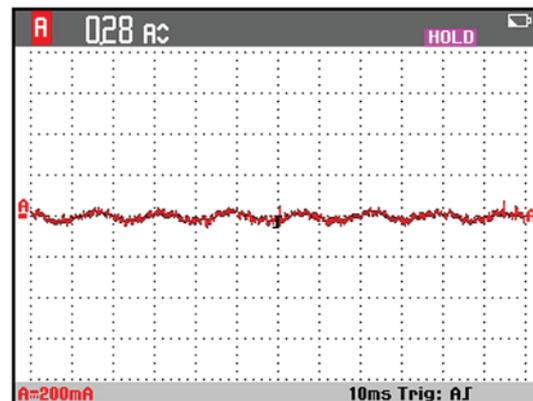
Figure 3. PE current.
