## Perfecting the art of energy efficiency

### Application Note

#### Testing Functions Case Study

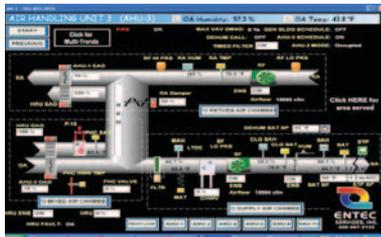
All air handlers in the Figge Museum's HVAC system are monitored through Delta Controls Building Automation system.

**The HVAC system for the Figge consists of:**

- Eight air handling units (AHUs) that provide conditioned air to various spaces using a variable air volume (VAV) system.
- More than 40 VAV boxes that control temperature and humidity to individual zones.
- Two chillers and cooling towers that provide mechanical cooling to the air handling units.
- Three boilers that provide hot water for perimeter finned tube and VAV reheat coils.
- A dedicated hot water loop that serves the frost prevention coils upstream of the energy recovery wheels in the AHUs.
- A garage fan ventilation system that provides fresh air in the parking deck
- A light shade control that provides the proper amount of natural sunlight in the gallery areas.

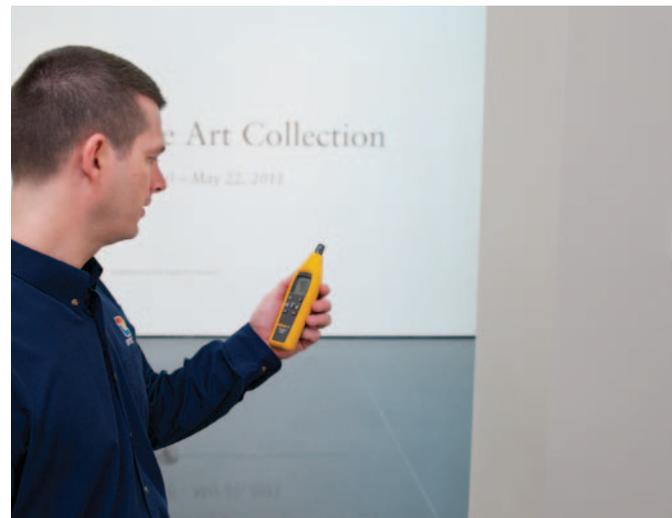
Mark Janco, System Specialist for ENTEC, uses a Fluke 971 to confirm that the temperature and humidity are at the optimum levels for a high-end art display.

Infrared Thermometer to measure the air temperature coming out of the ducts and to verify that the temperatures coming off the coils in the AHUs are adequate to keep them from freezing. He uses the Fluke 971 Temperature Humidity Meter to verify the humidity of the overall exhibit space. If those measurements show that the temperature and/or RH values are off, Janco uses the Fluke 971 to calibrate the controls to bring them back within the Smithsonian guidelines.

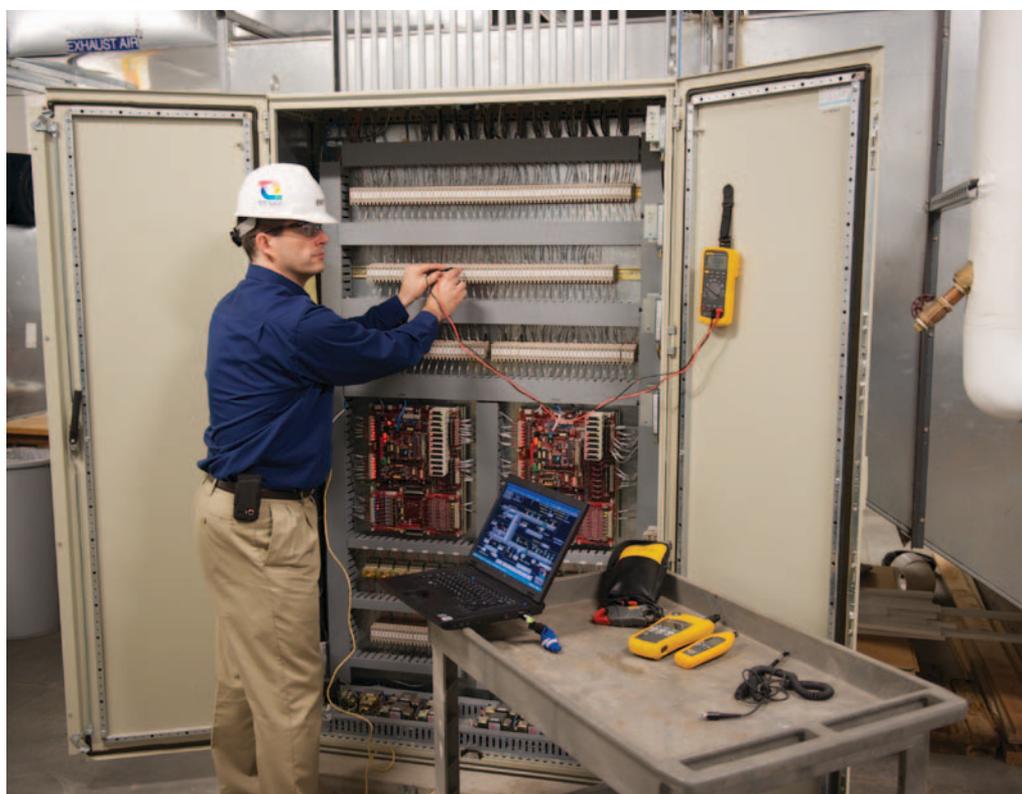
Mark Janco, System Specialist for ENTEC, uses his laptop with the Fluke 87V to tap into the Figge’s building automation system to run routing checks of various low-voltage HVAC system control centers.

Janco notes that the Fluke 87V Industrial Multimeter probably gets the most use of all his tools. He uses it for everything from checking the supply voltage in variable speed drives to checking fuses. “The Fluke 87V allows us to make sure that everything is working properly in the control aspect of the devices,” Janco concludes. It’s probably one of the most valuable tools we have besides our computers.”
