Restoring the electrical system of the USS *Pampanito*

Application Note

Testing Functions Case Study

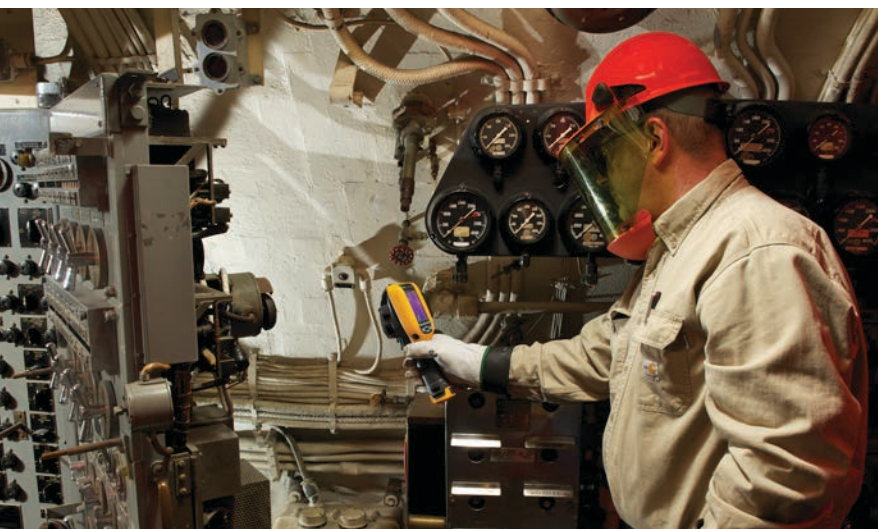
The control room is the center of the submarine, both physically and operationally. Bill uses a Fluke Ti125 to look behind the IC switchboard, which has both 120 volt ac and 120 volt dc systems.

Weindorf scanned two key areas of the electrical system—the lighting distribution panel and the IC switchboard. "The biggest challenge was finding the room to get a good camera angle, because obviously on a submarine you're dealing with very tight quarters," says Weindorf. "Since there was very little load on the electrical panel we didn't see much in the way of heat signatures, but we were able to detect some differences."

"The lighting distribution image showed a tiny bit of temperature rise, which probably shouldn't be there because it's very low current," says Pekelney. "That says to me that there might be some corrosion starting to form in that fuse holder." Following the inspection, Pekelney pulled any of the fuses that showed even a little bit of temperature rise and burnished up the contacts to make sure there was no incipient problem.
