METHODS FOR EVALUATING THE CONDITION OF PLATINUM RESISTANCE THERMOMETERS

Mingjian Zhao and Rick Walker
Fluke Corporation, Hart Scientific Division
799 East Utah Valley Drive
American Fork, Utah 84003-9775
Phone: (801) 763-1600
E-mail: mingjian.zhao@hartscientific.com

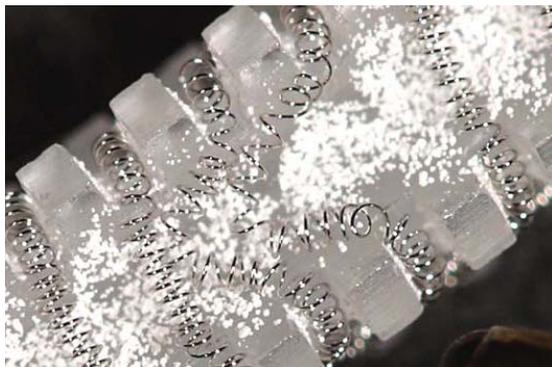
This sensor was damaged by shock during shipping and handling

Upon investigation of service records of SPRTs and PRTs, the primary cause of drift observed in SPRTs and PRTs has been improper handling. Being fully annealed, the platinum wire is relatively soft. Particularly with SPRTs, the sensor coils can easily move and touch adjacent coils, causing a short circuit, as can be seen in the examples shown in Figure 1. Here, one sensor was damaged by mechanical shock during shipping and handling, and the other was damaged by vibration.

This is typical behavior when there is a short circuit between sensor coils caused by severe mechanical shock. With a fused-quartz glass SPRT, the damage might be visible with a magnifying glass, as seen in Figure 1, but it is often less visible. An SPRT in such condition is no longer usable.

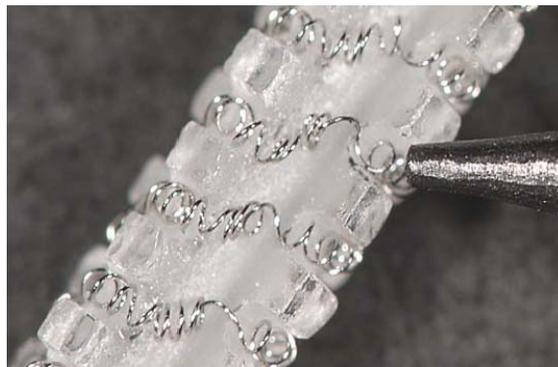
This sensor was damaged by vibration. Notice shorting of coils.

Figure 1. Shorted sensors due to mishandling

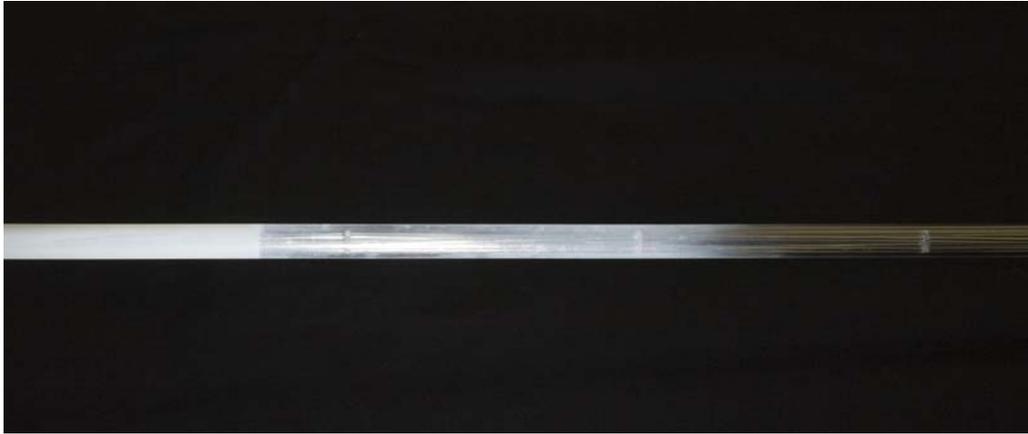
Devitrification of the fused-quartz glass appears as milky white corrosion on parts the sheath, as shown in Figure 2. It is caused by the chemical reaction of contaminants eating away at the surface of the glass at higher temperatures, particularly above 500°C. Devitrification generally will not affect the resistance characteristics of an SPRT, but it can reduce the mechanical integrity and lifetime of the instrument, and in the least it is unsightly. Once it occurs, it cannot be eliminated. But it can be avoided with reasonable care. The SPRT must be kept clean. The sheath should never be touched by bare skin, which contaminates the surface with oils and salts that quickly lead to devitrification when heated. Gently cleanse the sheath of the thermometer regularly with pure ethanol alcohol and a clean soft towel, especially prior to operation at temperatures above 500°C.

Figure 2: Devitrification of a fused-quartz glass sheath

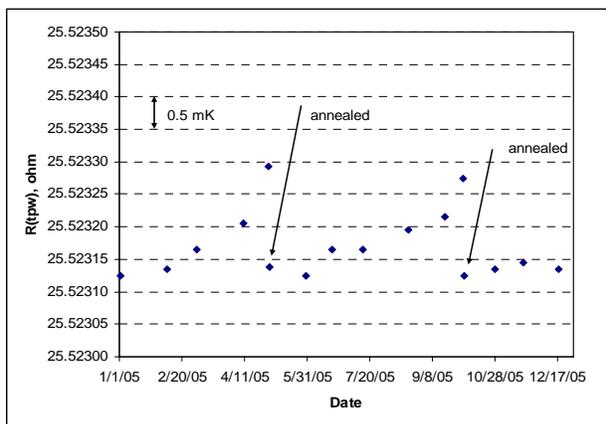
Figure 3: $R(tpw)$ recovery through annealing

This is common with SPRTs and PRTs. It is the result of platinum oxidization or slight mechanical shock. It is corrected by annealing. An example of this case is shown in figure 3. With an SPRT, it is recommended that $R(tpw)$ be monitored and the thermometer annealed when it drifts over 2 mK.

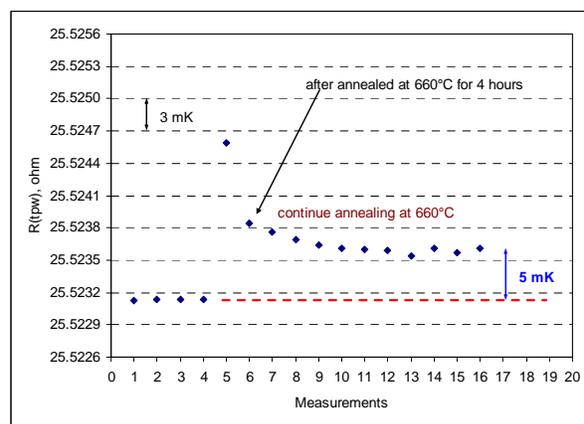
Figure 4: $R(tpw)$ partial recovery through annealing

This is usually caused by severe mechanical shock that has strained the sensor wire. The R(tpw) might be partially restored by annealing. An example is shown in figure 4. The thermometer should to be re-tested for stability. Even if it appears stable after annealing, it should be re-calibrated. It may be usable, but the accuracy might be slightly degraded. Take measures to prevent further mechanical shock.

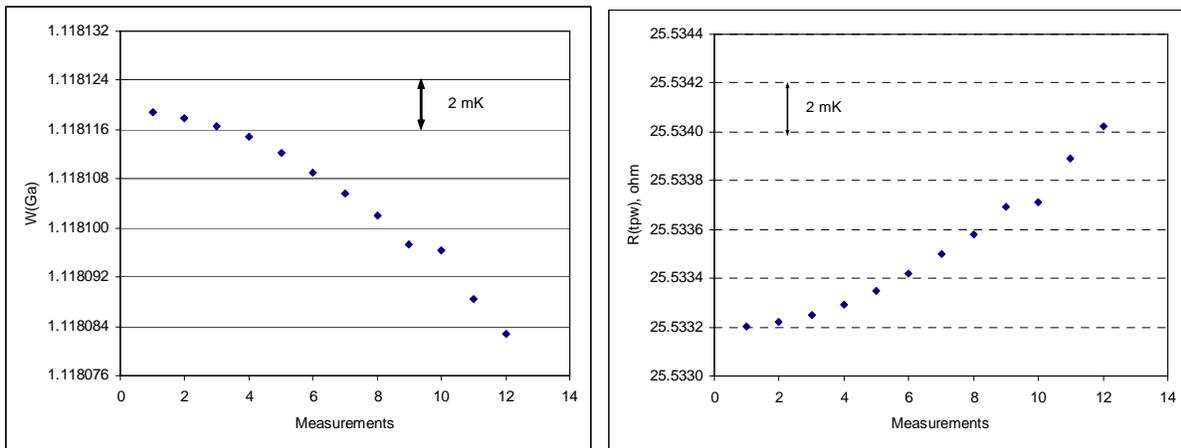
Figure 5: Contamination of an SPRT

The thermometer has probably received significant contamination. The R(tpw) will only shift more through annealing. Find the cause of the contamination and check if other thermometers have also been contaminated. Results of contamination are shown in Figure 5. If further contamination is avoided and the thermometer appears stable and the W(Ga) still meets the requirements of ITS-90^[2], the SPRT should still be usable, but re-calibration is necessary.
