Application Note

Testing Functions Case Study

Tool: Fluke Ti Series Portable Thermal Imagers

Profile: Keith Weyh, technical services supervisor at Adams Columbia Electric Cooperative

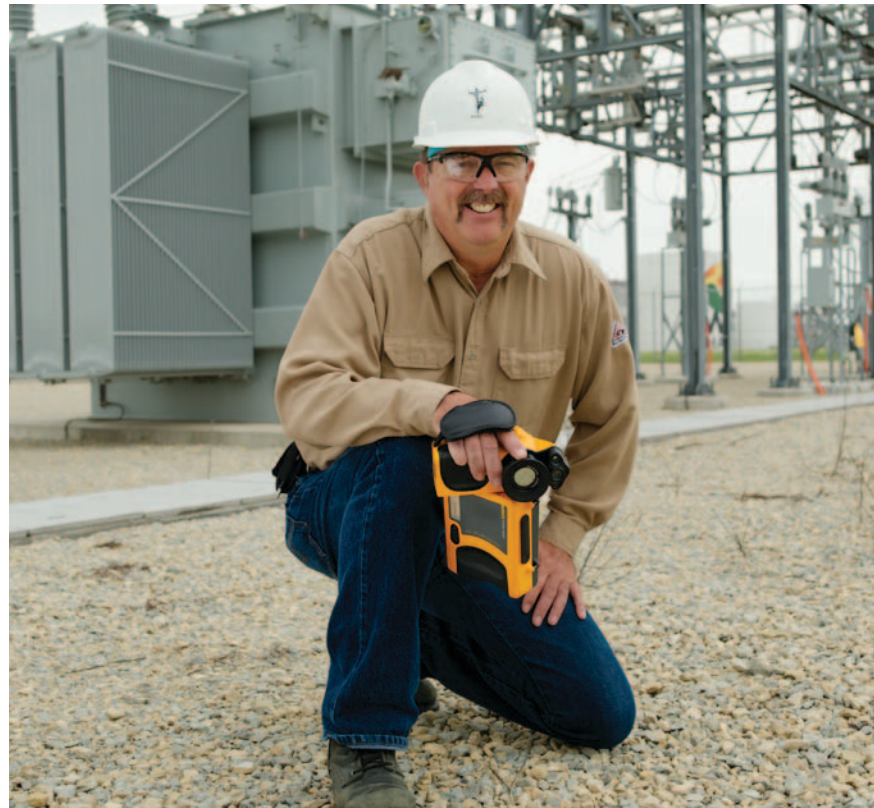
Adams Columbia Electric Cooperative monitors equipment health using thermography.

Using a handheld infrared imager, Keith Weyh, technical services supervisor at Adams Columbia Electric Cooperative, monitors the health of the co-op's equipment, the equipment of its members, and sometimes even the equipment of the transmission company supplying its substations.

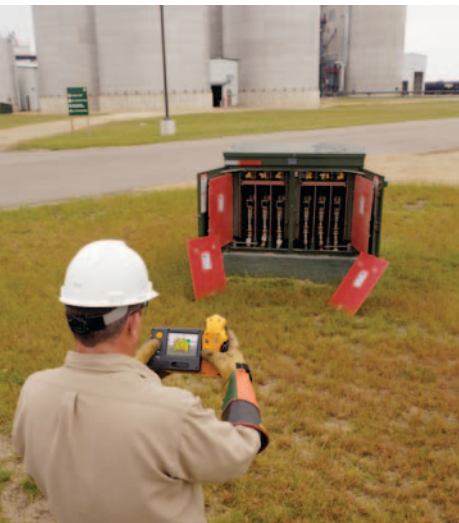
Bringing thermography in-house allows Weyh to help protect expensive equipment by scanning the ACEC-owned facilities on the sites of key co-op members.

Key accounts. Weyh considers seven of the co-op’s members to be key accounts. These, he inspects twice a year, scanning all of the ACEC-owned facilities on each site. The largest, the chicken processing plant, has a complete substation dedicated to it, and it has dozens of the utility’s transformers on site—eleven 2000 kVA units plus numerous other small ones.

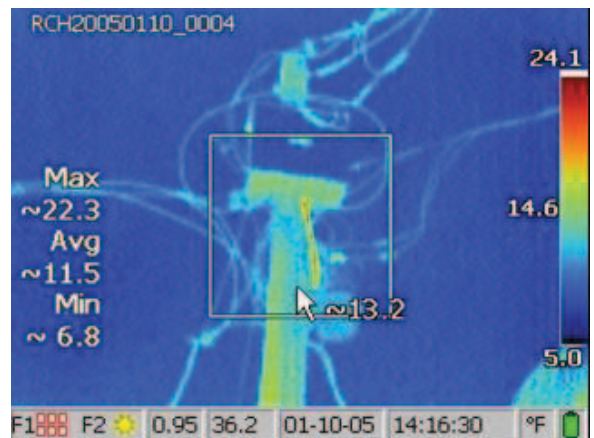
Taking a thermal image of this pole top located on a dairy farm made it easy to see that there was a problem.

To underscore the fact that most utility problems are easy to spot, Weyh reports on the inspection of one farm pole where he used the infrared camera to determine there was a problem even though the actual temperature of the pole top was outside the calibrated range of the instrument. He notified the co-op member, who contacted an electrician and scheduled repairs for the following week. Unfortunately, the pole top burned up before repairs could be made.
