15 powerful applications for the Fluke Visual IR Thermometer

Application Note

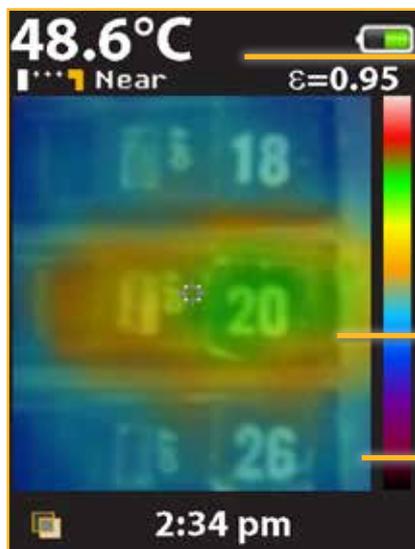
Every Fluke Visual IR Thermometer has a built-in digital camera with a thermal heat map overlay to instantly identify the exact location of the problem.

Centerpoint temperature (°C/°F)

Digital image for context

Clearly see that breaker 20 is overloaded and communicate your findings.

Thermal heat map overlay

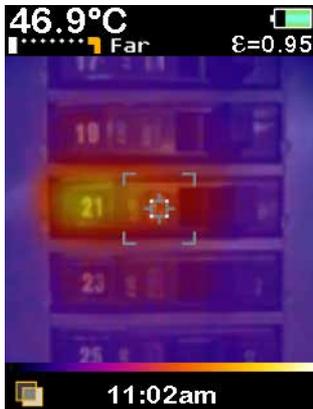
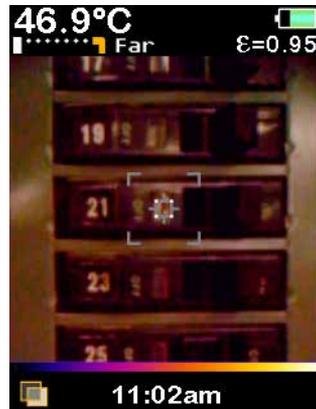
1. Overloaded circuit breaker

Scan large electrical panels in seconds to find potential faults that generate heat, such as loose connections, imbalance or overloading.

Notice how the visual IR thermometer not only shows an apparent hot spot on a breaker, but the digital image also shows the exact location where the potential problem lies.

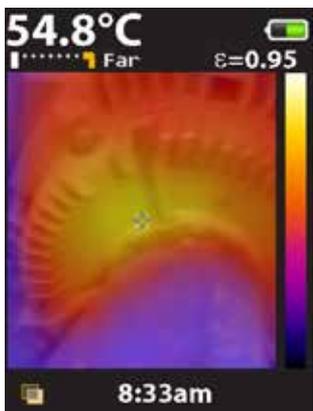
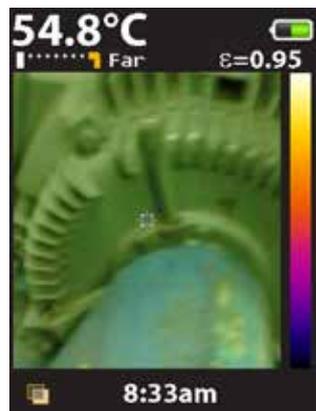
2. Overheated motor output

This image reflects a motor that may be overheated based on the center point measurement of 54.8 °C.

The combination of the thermal heat map and field of view in tight spaces is powerful orientation when troubleshooting and communicating needed repairs to others.

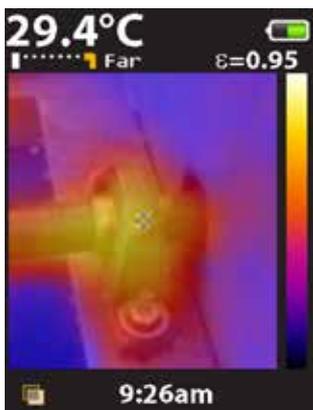
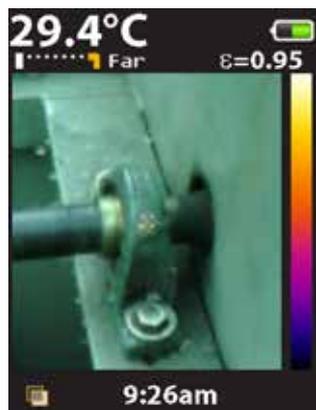
3. Thermal inspection of bearing

The visual IR thermometer can be used to scan bearings to compare temperature readings with past inspections or with other bearings operating under similar conditions. Establishing temperature benchmarks with the Fluke Visual IR Thermometer can become an important part of your preventive maintenance regimen.

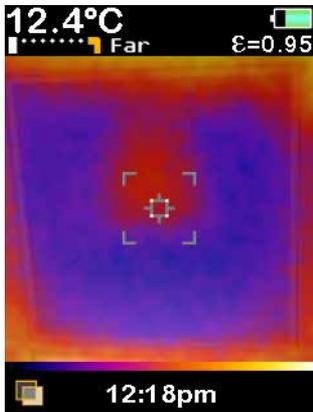
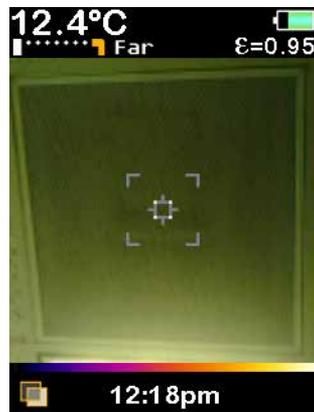
4. Potentially faulty cold air damper

Use your visual IR thermometer to see how well the VAV box is working by scanning vents. The warm area in this otherwise cold vent could indicate a faulty cold air damper.

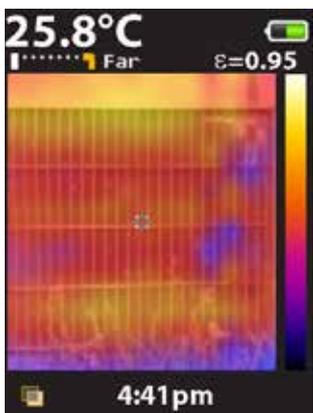
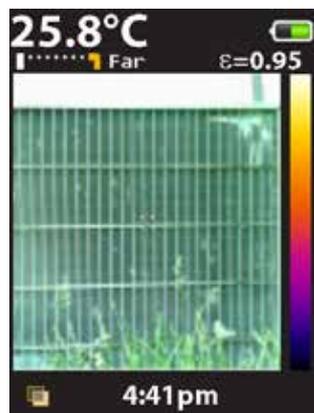
5. Uneven distribution in AC condenser

In this typical AC condenser, the uneven distribution of heat in the center row may indicate a potential issue.

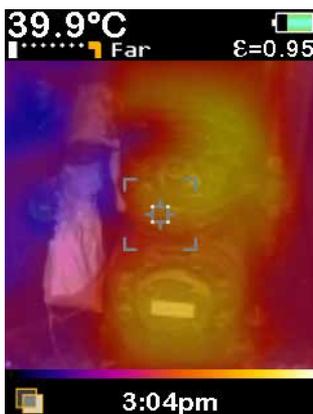
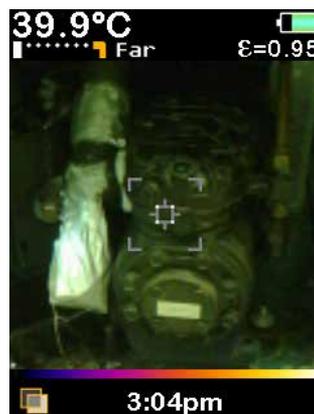
6. Inspection of compressor thermal expansion valve

The thermal heat map allows you to quickly scan the compressor and determine that the TXV (thermal expansion valve) to the left appears to be cold, indicating that it is closed.

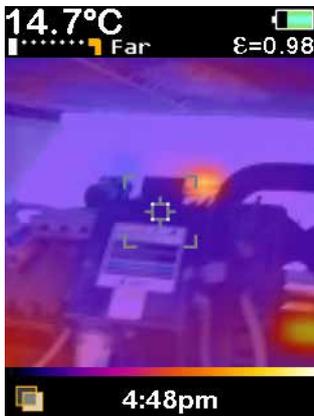
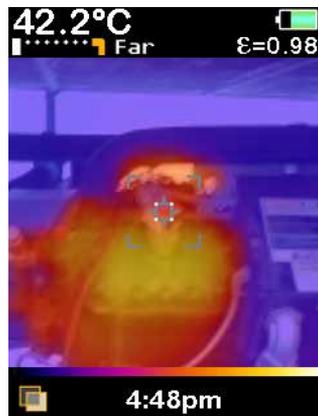
7. Non-operational AC compressor

Stage 2 Compressor

One of the Operational Stages

The compressors in these images are running on a 4-stage system. The second stage compressor appeared cold, while the other three compressors in the system all appeared hot. This compressor will need to be further investigated.

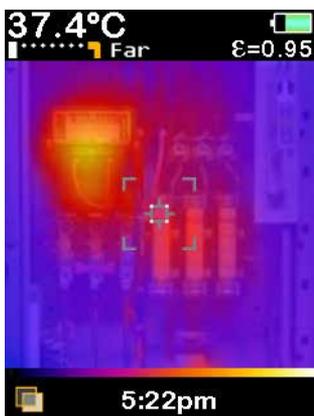
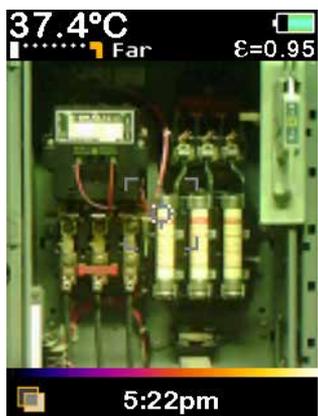
8. Thermal inspection of combination starter

Use a Fluke Visual IR Thermometer to look for connection or overload conditions in combination starters. Alarm features on the VT04, as well as the universal tripod mount, can help you troubleshoot intermittent issues unattended.

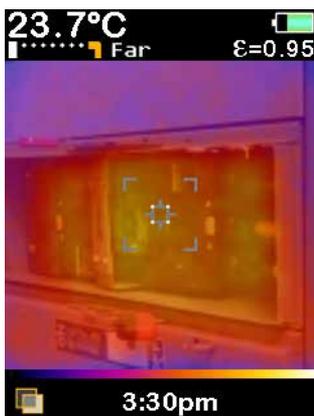
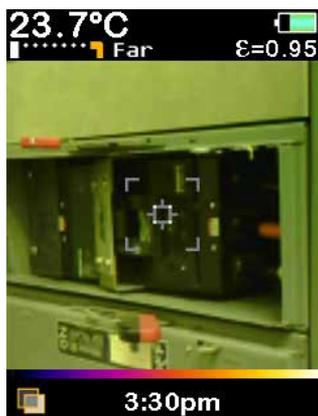
9. Main breaker for mission critical equipment

This main service breaker controls the main breaker panel for the company's IT department. A fault could cause an outage of mission critical data center equipment.

The thermal inspection of this important breaker indicates that there is even heat distribution which signifies that there does not appear to be anything wrong.

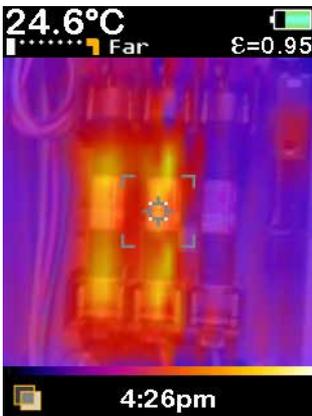
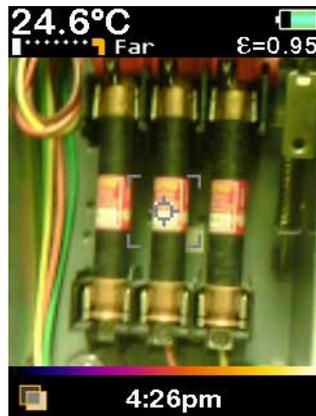
10. Unbalanced load in three phase supply

Quickly identify apparent unbalanced loadings. In this image, the fuses are connected to a water heater, and the most likely scenario is that the two fuses on the left are being used more than the fuse on the right. This could indicate a problem with the heating element in the water heater. If this were single phasing, it could indicate that the fuse on the right may be blown. The next step is to check continuity of the fuse and current loads on the 3 phases.

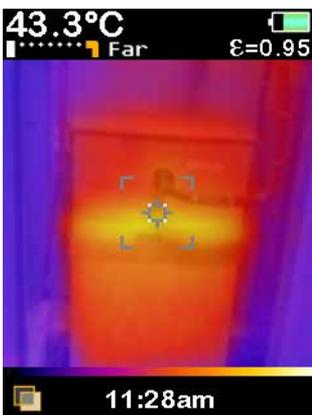
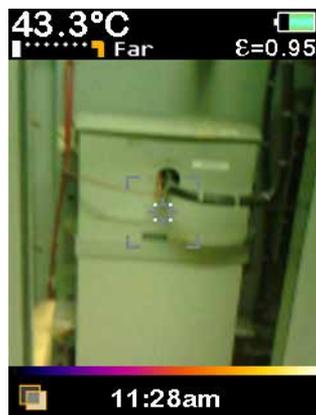
11. Power factor correction capacitors

Power factor correction capacitors will usually run warm when they are operating correctly. A failed capacitor will show up as cool in comparison with the operating capacitors.

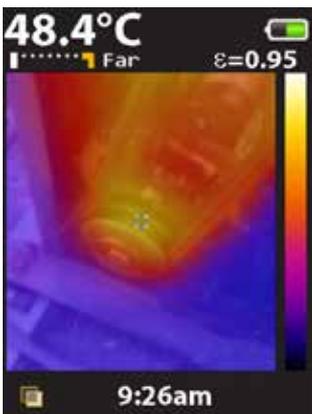
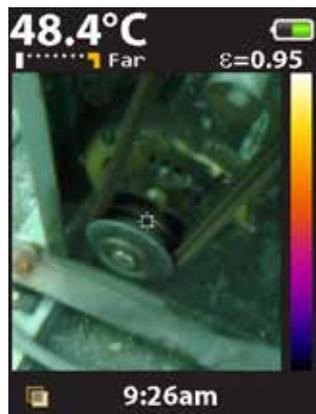
12. Preventive inspections of pulleys and belts

If a pulley appears warmer than expected, you'll want to inspect the belt to ensure there is no slippage, misalignment, or damage to the belt. A quick scan with the thermal heat map on the visual IR thermometer can help you quickly detect a temperature change that may be cause for further investigation.

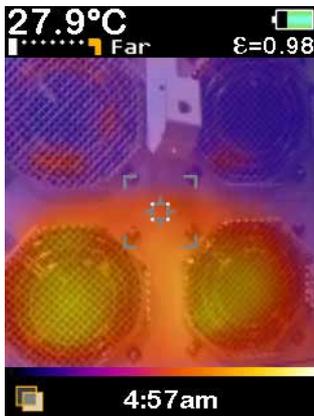
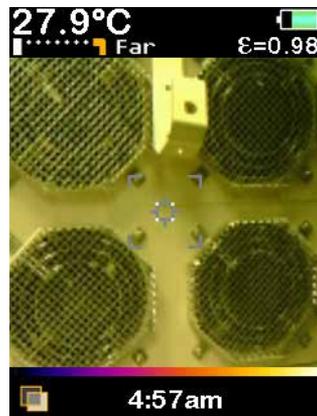
13. Environmental monitoring of fan for high-powered equipment

If a fan starts to seize up, workers in the area may not notice until there is a burning smell. However, a quick scan with the blended thermal heat map reveals the hot and cold areas to help determine if the fans are functioning as expected.

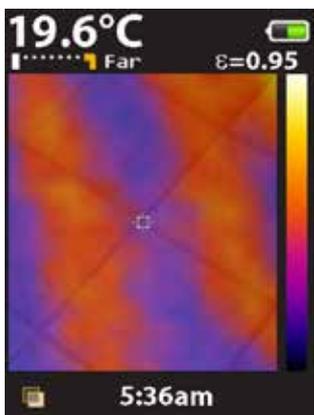
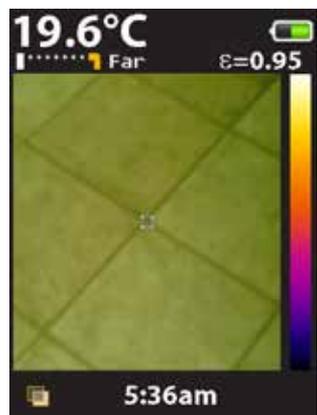
14. Troubleshoot issues with radiant flooring

This radiant flooring was scanned to check for the expected heat pattern. For best results, leave the radiant system off for 24 hours to cool down. Power on the system again and scan the flooring to check for the expected thermal heat pattern.

To find potential issues in electrical-based systems, look for cold spots that are anomalies in the normal heat pattern. For hydronic systems, look for cold spots or a spreading hot spot that could indicate the pipes are leaking.

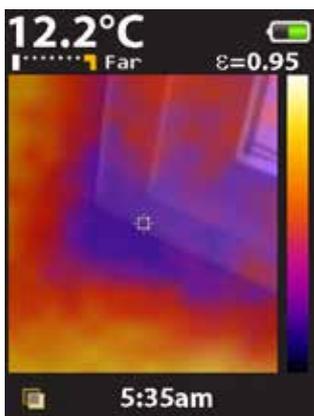
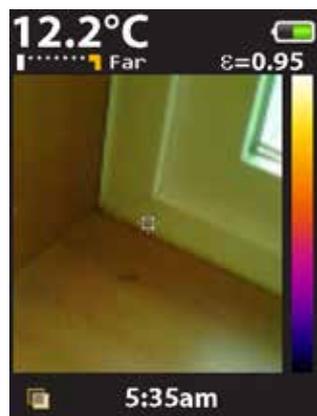
15. Heat loss from windows and doors

The Fluke Visual IR Thermometer can help you find a broken or damaged window seal that is allowing a cold or warm draft to occur around windows or doors.
