Thermal building inspections bring heating and cooling losses to light

Application Note

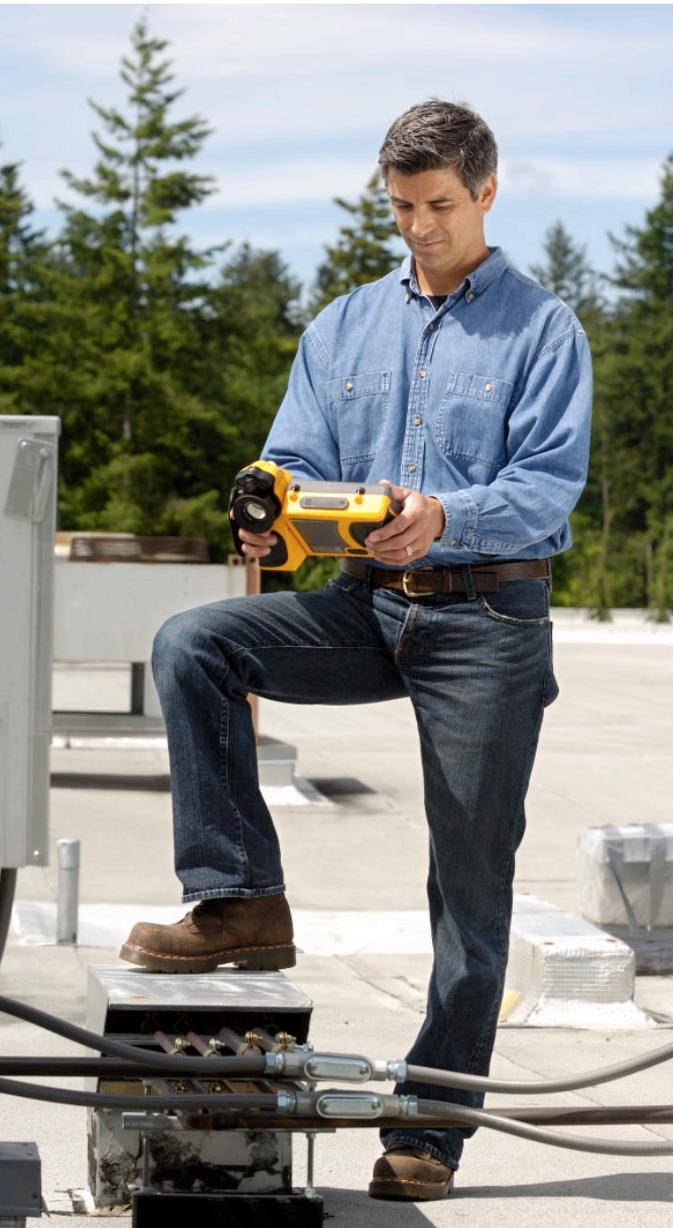
Performing a routine roof inspection to search for moisture (leaks and wet areas) in the roofing materials. **Note:** These tests are typically done at night, this photo is for marketing purposes only.

Roofs. Wet insulation is the primary cause of premature roof failures and high roof maintenance costs. Scan roofs after a hot day. Any detectable moisture will retain the heat of the day while surrounding structures and insulation cool. Nanji notes that different types of insulation result in different thermal patterns. Therefore, knowing what type of insulation is in a roof and the thermal pattern it will create in the presence of water can be very helpful in detecting moisture in a roofing system.

Note: Because water absorbs heat slower than dry surrounding structures, roof inspections could be carried out at dawn as well as dusk with wet areas appearing as cooler than the dry parts. “However,” Nanji observes, “the industry norm is for the inspections to be carried out around dusk.”

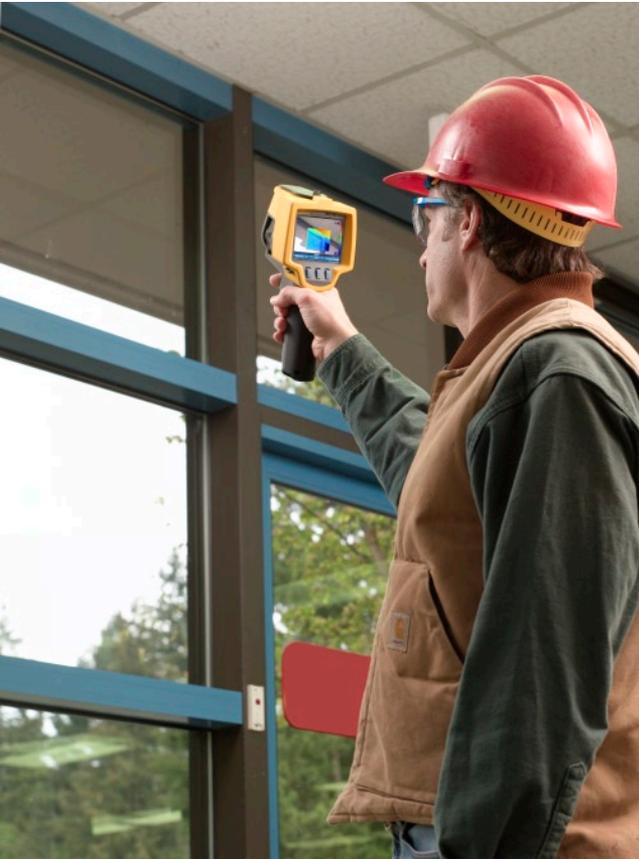
Checking for moisture within the wall surface with a Fluke InSight Thermal Imager.

Walls. During an external scan of a building under the right circumstances, a thermal imager can pinpoint moisture in walls in much the same way it can in roofs. Of course, water in walls (or roofs) will lead to mold and mildew, adversely affecting occupants who are allergic to such spores. Also, in walls (as in roofs), wet absorbent insulation will have lost its effectiveness and should be replaced. The latter situation is tantamount to a wall being partially insulated, which also will manifest itself under the right circumstances, even when moisture is not present.

Walls. Scan outside walls any time a difference in indoor and outdoor temperatures exists naturally as in winter or summer or when a significant Δt can be created artificially by elevating the output of the heating or air-conditioning system. As with roofs, when screening for moisture in walls, early morning or evening of hot days can create a significant temperature difference that will produce revealing thermal images. Of course, dusk is the best time to monitor west walls, and dawn is best for east walls. Either works for south walls in the Northern Hemisphere, but north walls may not heat up enough naturally to yield revealing thermal images.

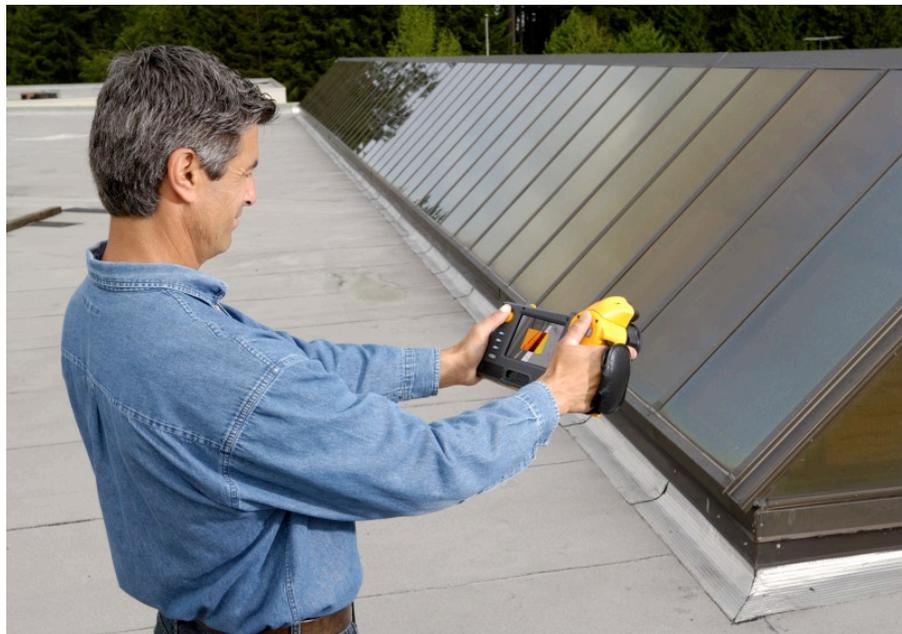
Facilities manager checks the roof flashing to make sure there is no moisture penetration.

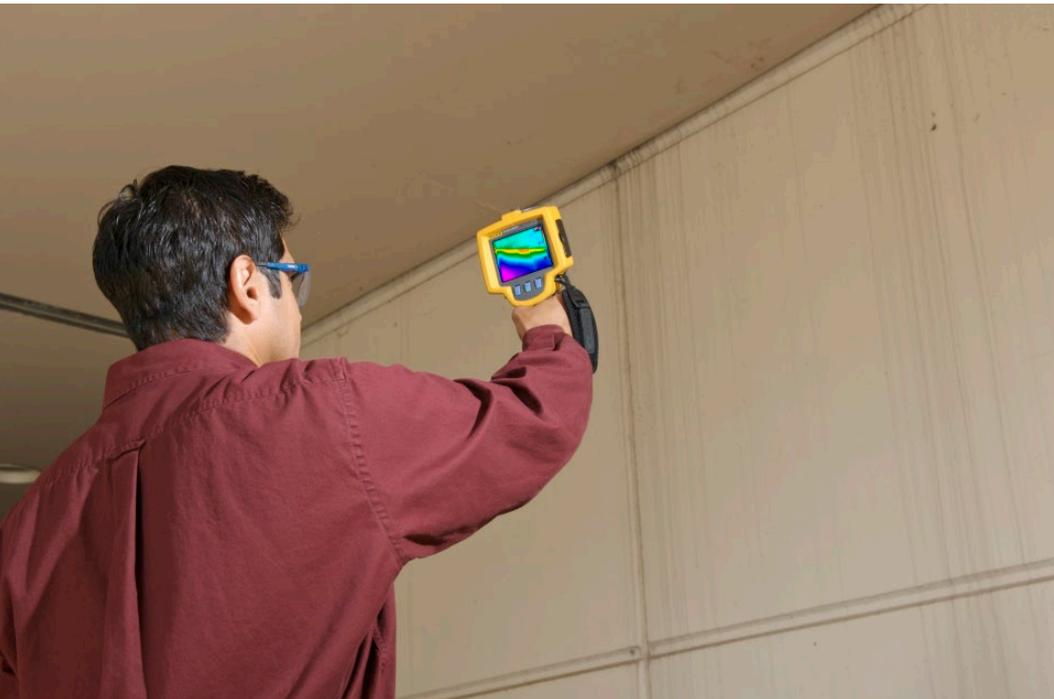
A technician checks the extent of moisture damage.
