## What to do when indoor environments demand precise humidity controls

### Application Note

### Air Quality Case Study

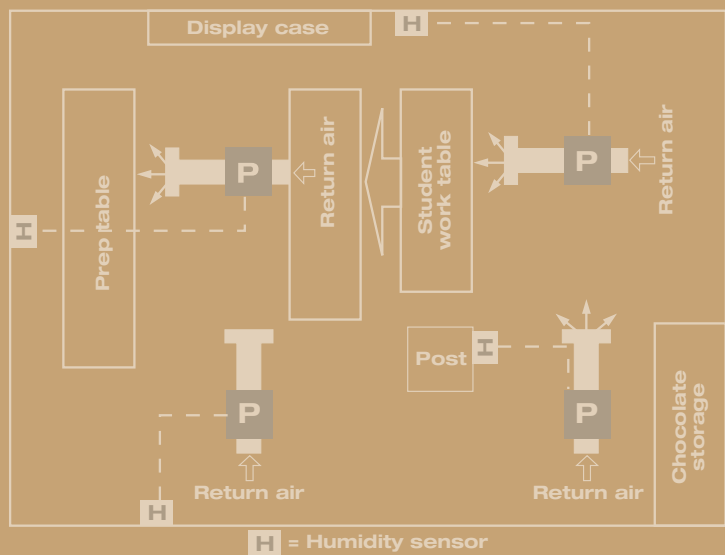
**Chocolate room humidity measurements**

Measurements taken within one day. Please see floor plan for sensor placement.

**Sensor #4**

9:29 AM Start  
 9:36 AM Finish (7 minutes instrument settle time)  
 Fluke: 54 % RH, 20 °C (68 °F), 938 ppm CO<sub>2</sub>  
 Readout: 73.4 °F, 62.3 % RH

**Sensor #3 (Unmarked)**

9:36 AM Start  
 9:40 AM Finish (4 minutes settle time)  
 Fluke: 50 % RH, 20.3 °C (68.54 °F), 863 ppm CO<sub>2</sub>  
 Readout: 73.7 °F, 61.4 % RH

**Sensor #2**

9:42 AM Start  
 9:46 AM Finish  
 Fluke: 20.5 °C, 49.8 % RH, 890 ppm CO<sub>2</sub>  
 Readout: unclear

**Sensor #1 (Inaccessible)**

Placed Fluke on cooking prep table in front of instructor during class.  
 9:46 AM Start  
 9:50 AM Finish  
 Fluke: 20.8 °C (68.9 °F), 49.4 % RH, 904 ppm CO<sub>2</sub>  
 Readout: 60.9 % RH, 74.1 °F

Placed Hobo's at 10:00 AM

#2 on #2, #1 close to #1  
 Tests taken while class running with a load of approx 21 people and cooking equipment running.  
 Outside air conditions at time of test:  
 10:18 AM, 17.8 °C (64.04 °F), 54.7 % RH, 632 ppm CO<sub>2</sub>
