## Ensuring hospital robots stay 100 % reliable

### **Application Note**

# Testing Functions

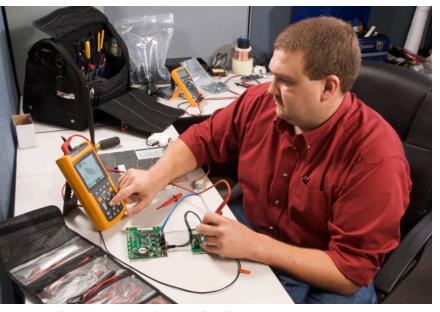
Evaluating power signals with his ScopeMeter.

In another test, Jesse was investigating why the robot's battery life was less than expected and the servo motors that drive the robot were prematurely burning out using a newly designed motor controller board. Jesse had previously built a small device that he uses to measure the power being delivered by the battery. This device places a 1 k $\Omega$  resistor in series with the battery cable. Jesse used the Fluke 179 Multimeter to measure the voltage across the resistor and stored the maximum voltage in the meter using its Min/Max/ Average feature. Jesse then used

Ohm's law to calculate the power provided by the batteries. He let the robot proceed through its rounds but stopped it every 50 feet to determine the maximum amperage provided during that period. Over the vast majority of the route traversed by the robot, Jesse determined that the amperage was normal.
