Safety at an asphalt plant

Stepping away from arc flash hazard

Application Note

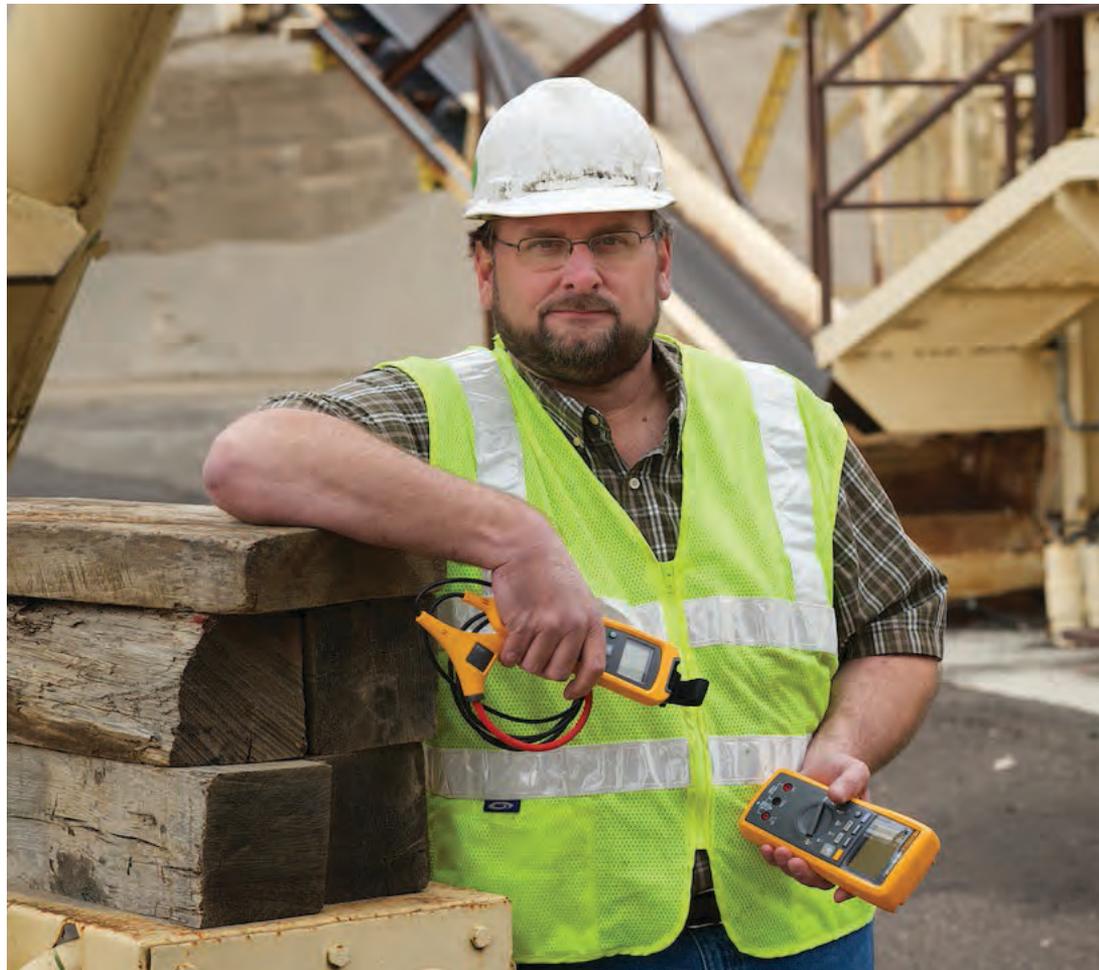
"Something had burned up, or flashed. My first thought was I was glad nobody was in the room. My second thought was the Connect...did what it was supposed to do."

“It caused that thermal overload section of the motor starter to literally blow up and explode”

“The weakest link in our circuit was the thermal overloads in the motor control center,” Conover said. “When that shorted it caused that thermal overload section of the motor starter to literally blow up and explode. It actually burned the overloads themselves into multiple pieces. The thermal overload had to be completely replaced before we had the chance to run it again.”
